## Conservation Condition Survey

### *Victorian Organ Case*

by Gilbert Scott Jr and Thomas Kempe, ca. 1870

St Michael and All Angels Church  
Moccas, Hereford

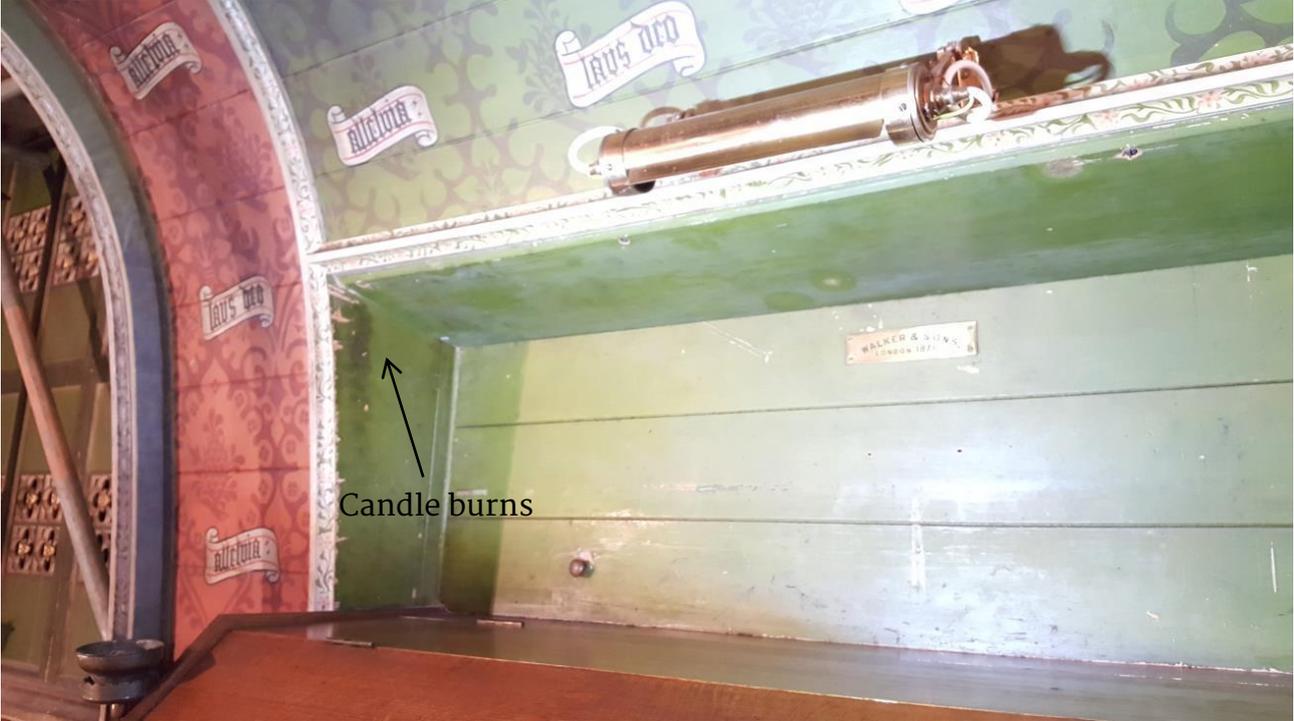
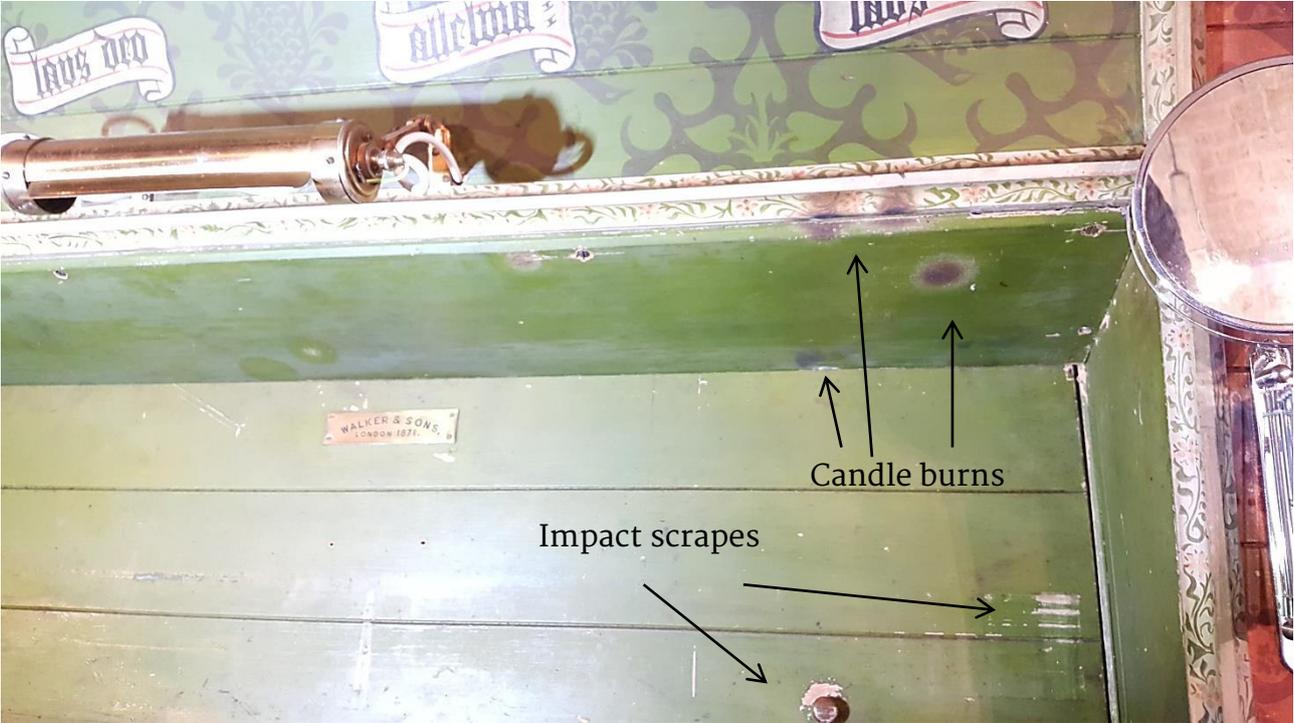
The paint layers are in a reasonable condition and the paint film remains generally well adhered to the wood substrate. There are impact damages that are visible as areas of abrasion and loss in the paint surface. This is more frequent in the lower half of the casing. Otherwise, the paint film remains flat and secure showing no signs of age or drying craquelure. The paint losses interfere with the visual appearance of the scheme: dirt and grease deposits have gathered preferentially on those damaged areas, and the colours appear subdued as a result. There are sporadic liquid splatter deposits and candle burn marks under the curved section above the key-desk.

Swell organ casing showing burn marks and general wear and tear.

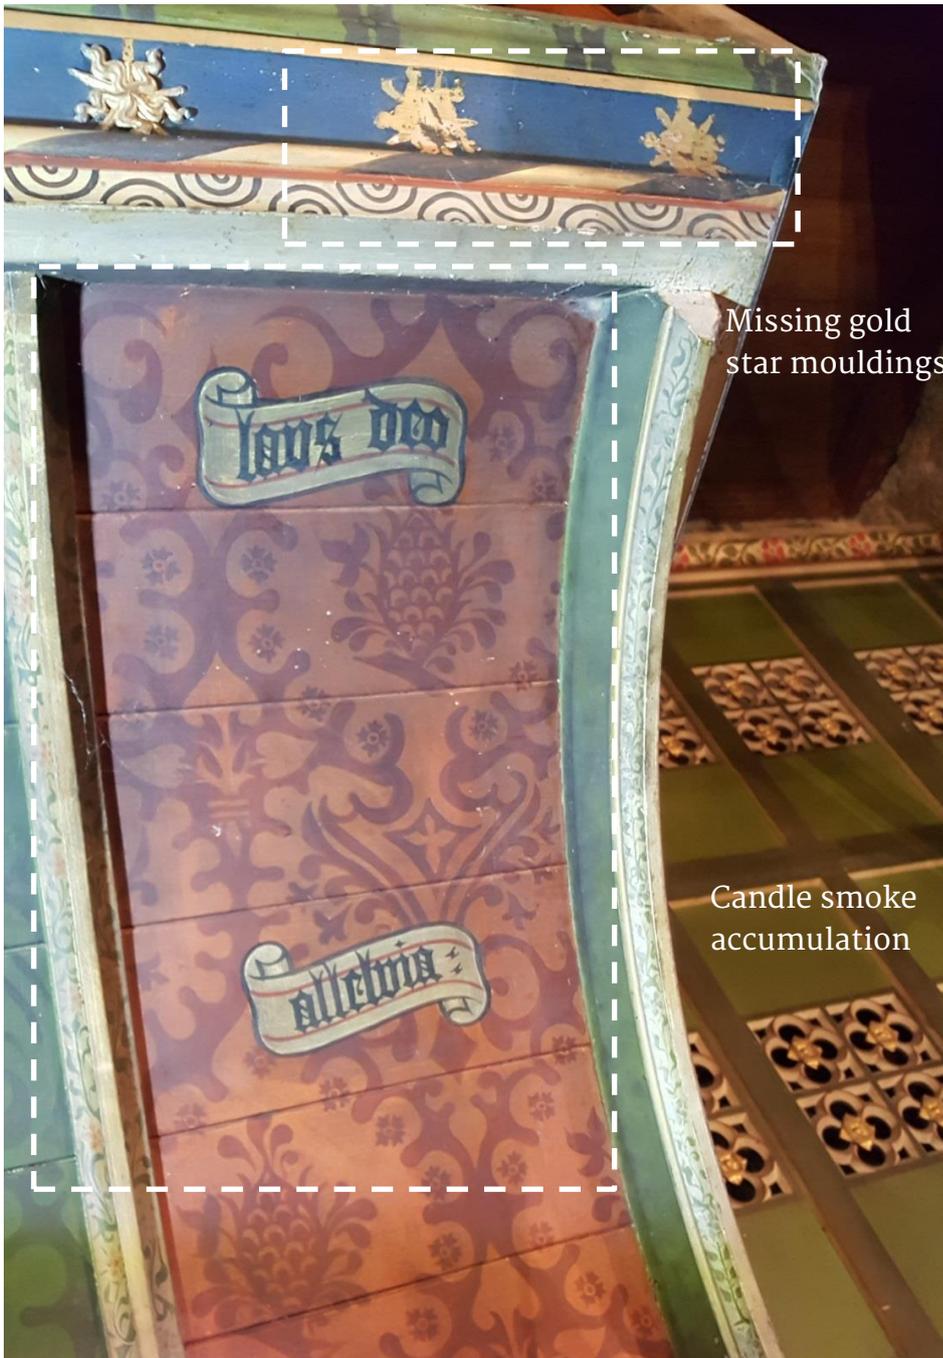
The wooden structure is in very good condition displaying no signs of mechanical stress such as twisting, warping and splitting of the timber. There is also no evidence of wood worm damage, contrary to the adjacent old timber arched features and ceiling. All the carving is mostly intact apart from the decorative gilt stars running along the central horizontal blue border. Twenty stars are currently missing; one star is entirely detached and a few minor remnants of other stars are still visible in place.

Missing gold  
star mouldings

Candle smoke  
accumulation

The missing stars would be re-cast in plaster of plaster by taking a moulding from the extant original. They would be attached to the blue border using Paraloid B72 adhesive (stable and reversible conservation adhesive) or a stronger polyvinylacetate, if necessary. The stars would receive a coating of yellow bole and gold leaf 22 1/2 ct. affixed with size or oil mordant – to be discussed. The gold would be patinated to blend in with the original gold.

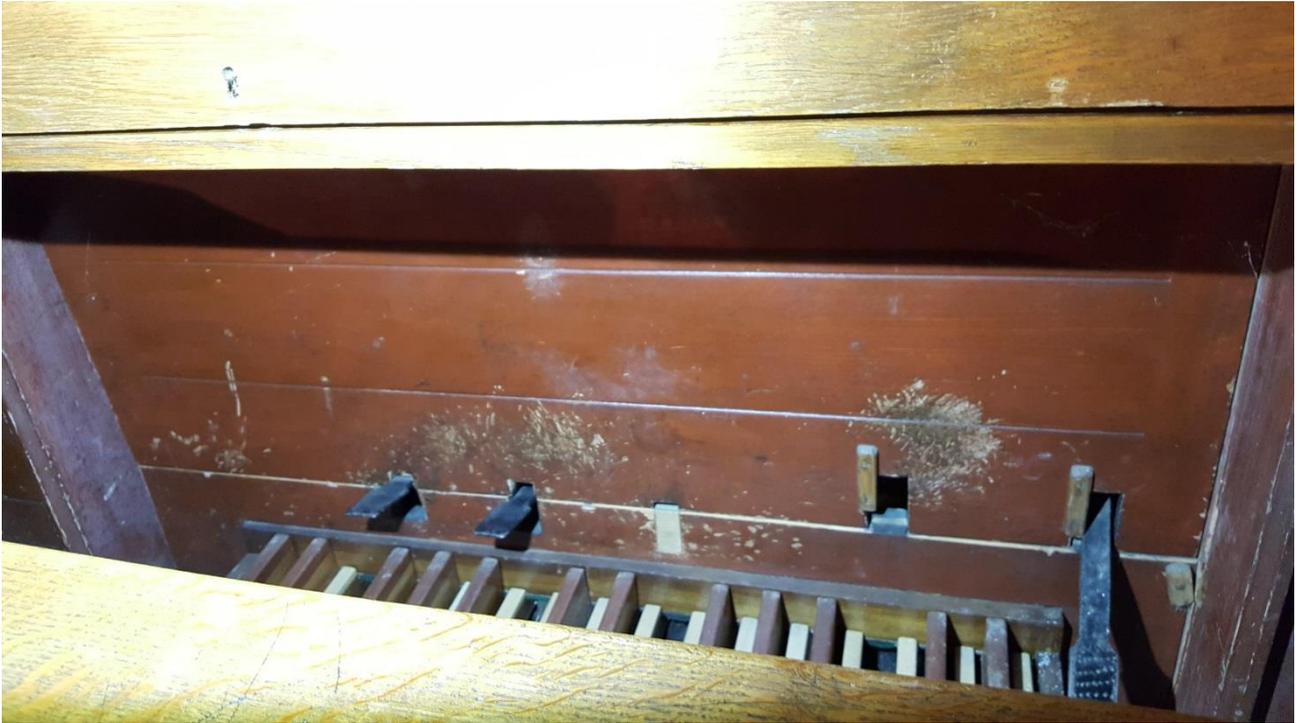
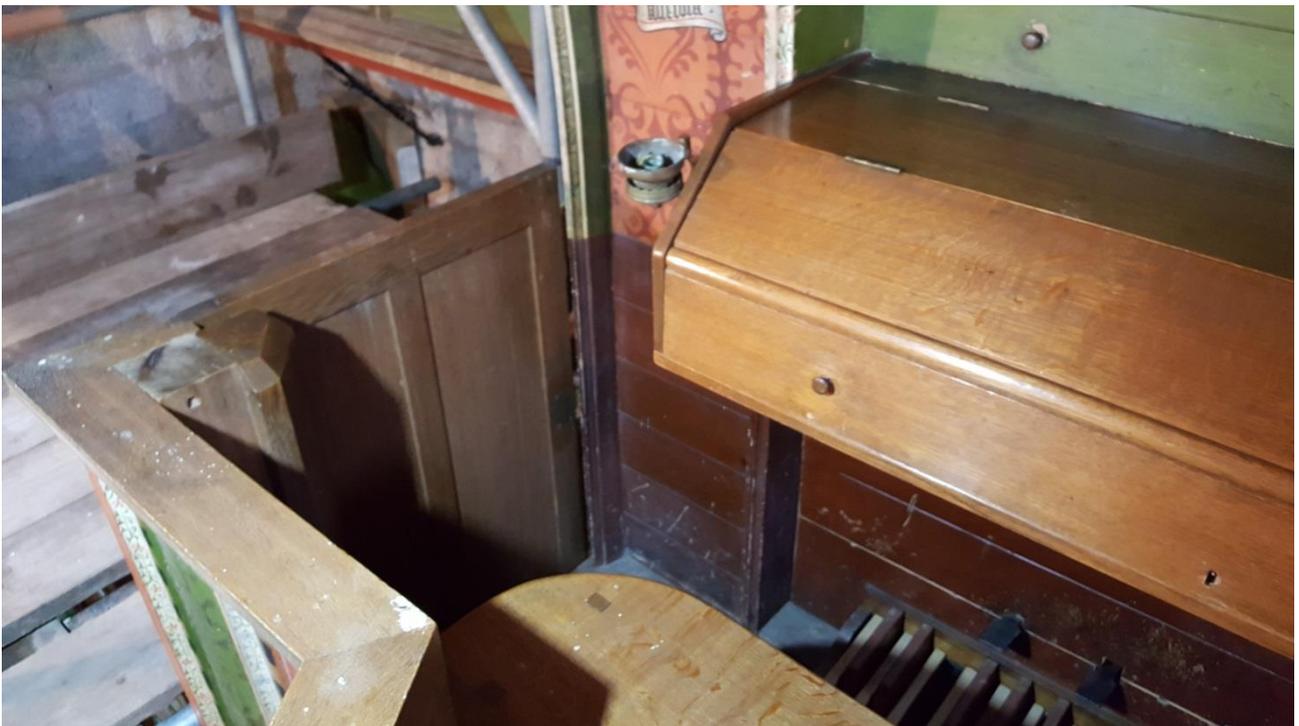
Swell organ showing general wear and tear damage, impact scuffs and scrapes near the pedals and balcony sill.

Although not in immediate danger of spontaneous delamination, those areas of paint loss should be consolidated and re-laid as a priority. They will remain vulnerable, and further loss is likely to develop rapidly as environmental factors can now affect the paint surface. If dust and debris is able to enter through lifted paint, this will compromise the future stability of the paint layers, and render future conservation treatment more complex. The brittle edges of losses are also currently prone to fracture and thus further loss of small chips of paint. If re-laid, flat to the wood, the edges will be protected from potential physical damage – consolidation is a prerequisite to surface-cleaning, as there will be a danger of cotton-wool fibres catching in the surface and pulling entire flakes off.

Paint losses, abrasions and blemishes would be filled with a soft water based putty and retouched to match the surrounding paint. This could be carried out with gouache base coats and glazes of powder pigments in Paraloid B72 acrylic varnish to re-integrate the paint film fully. This is a stable but reversible retouching system. The screw heads will be left visible if the screws are useful for access and maintenance of the organ equipment.

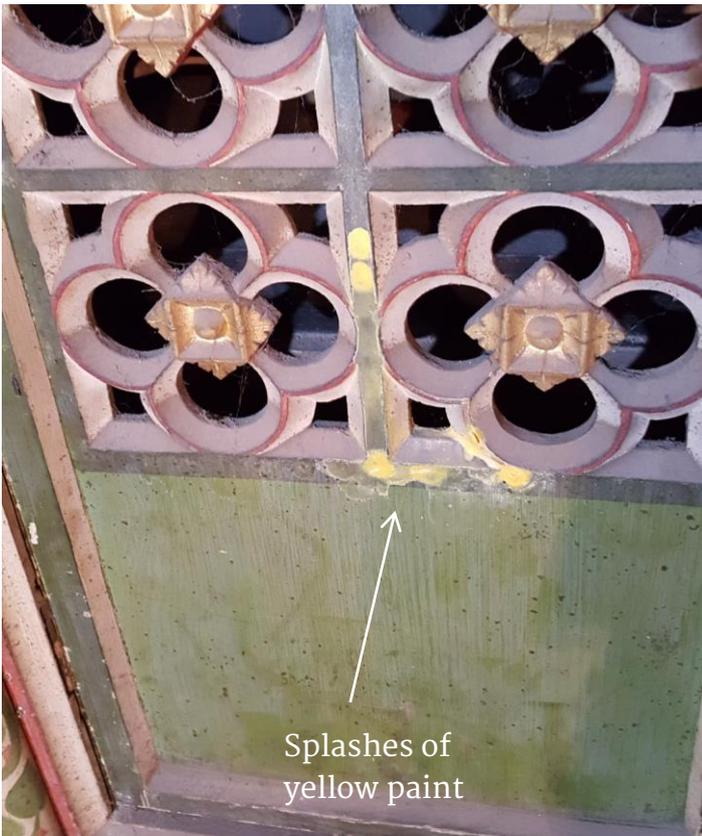
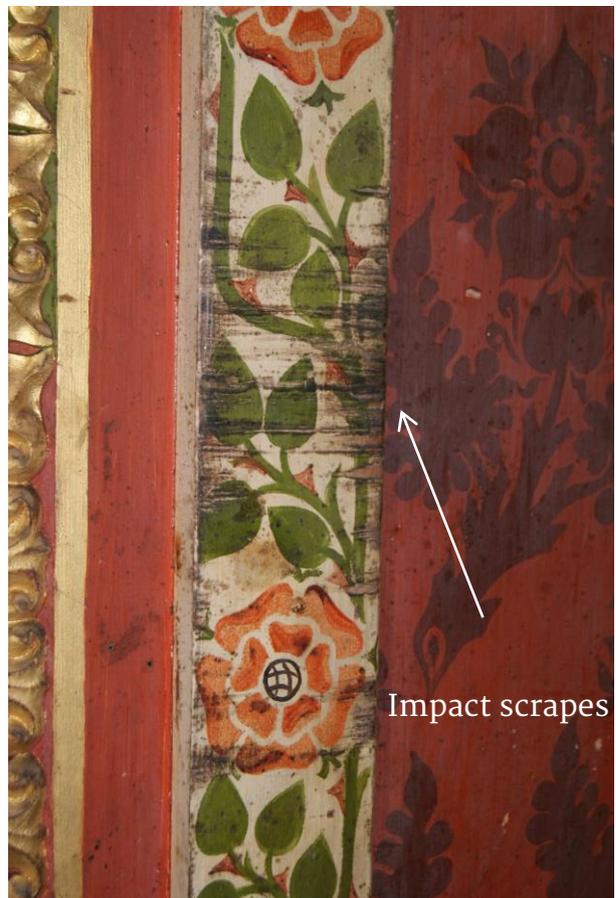
Details showing residues of yellow paint splatters over the original paint work (above) and impact scrapes across a rose and petal decorative band (right).

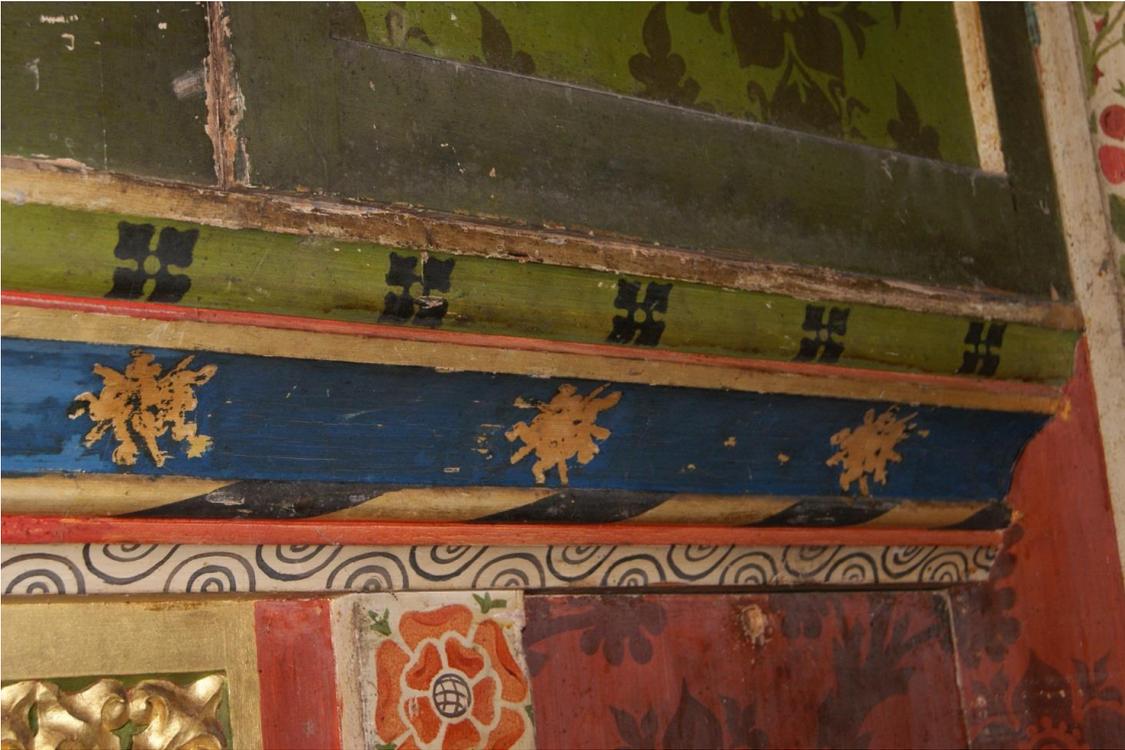
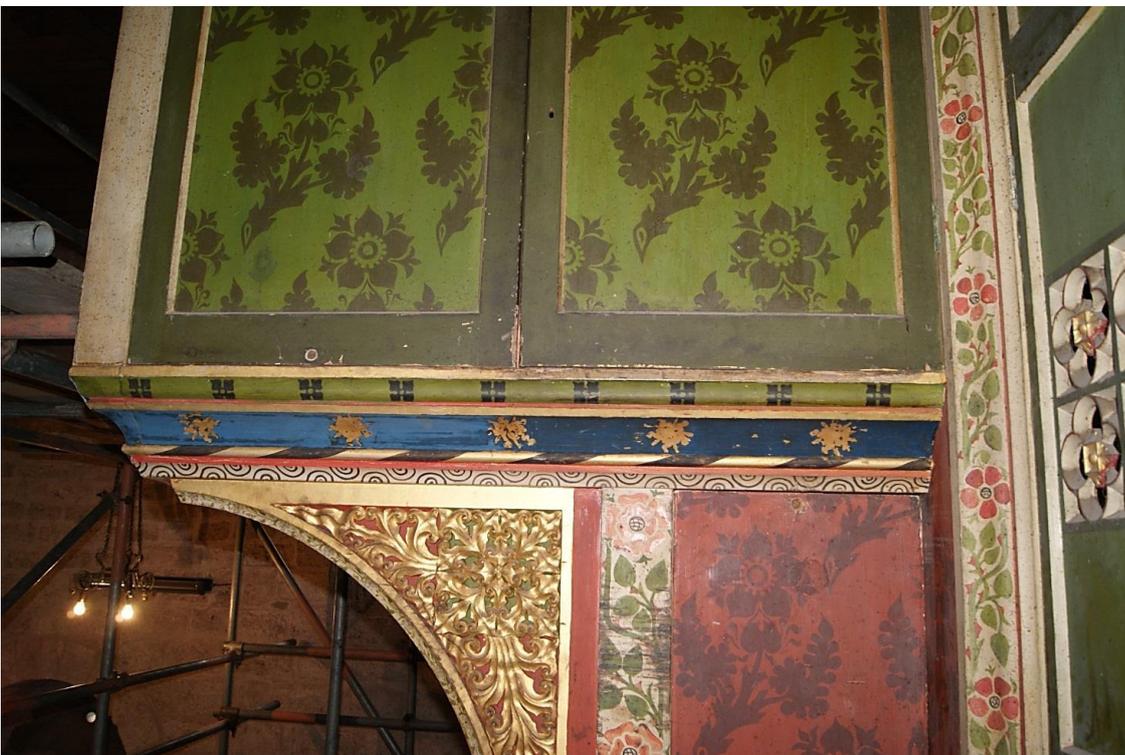
An area to the right side of the organ casing displays evidence of paint damage and degradation, mostly due to wear and tear. The majority of the gilt star mouldings are currently missing and detached from the blue ornamental border. This has partially faded along a section of the right hand side.

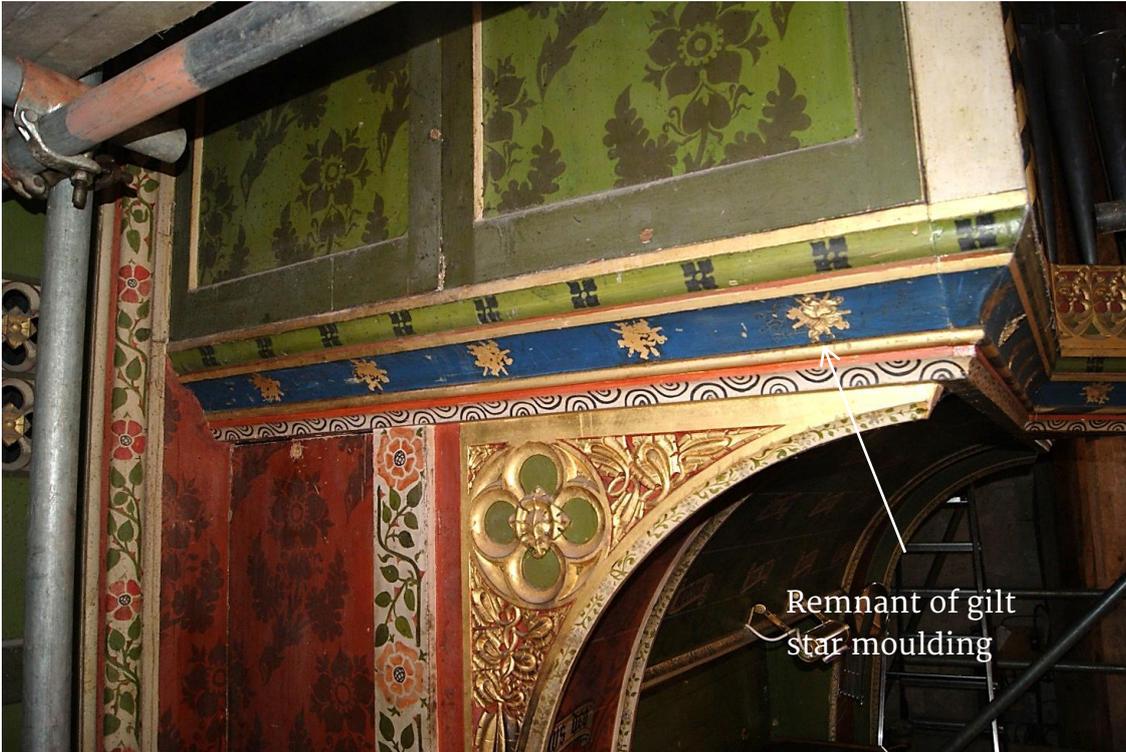
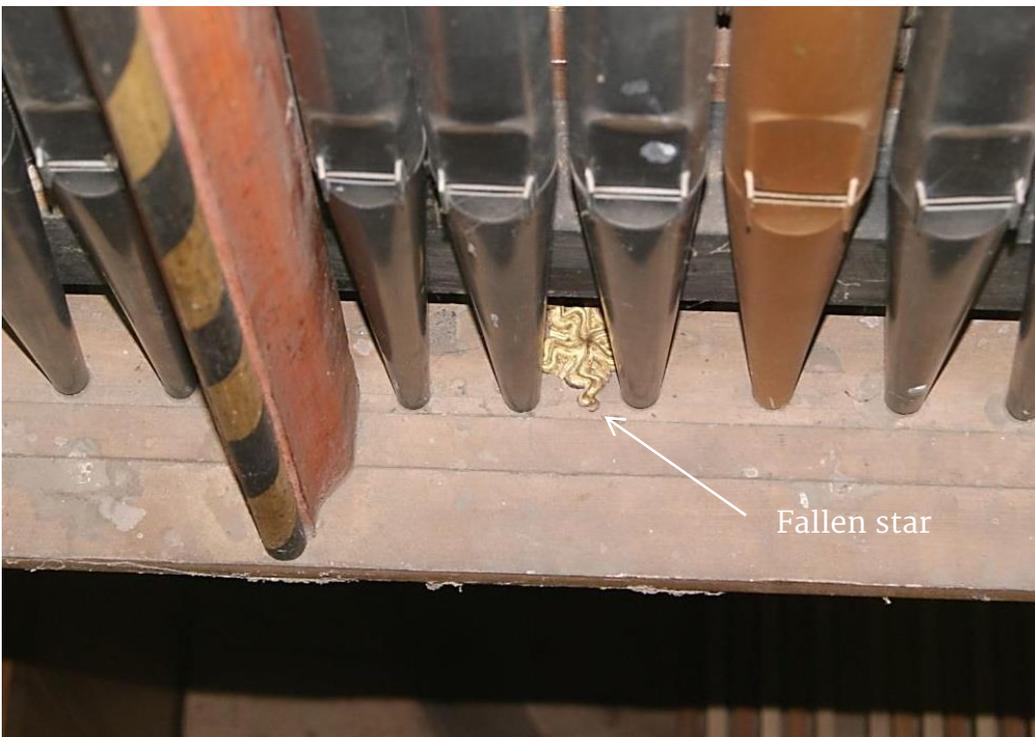
Area to the left side of the organ casing showing evidence of paint damage and degradation. A few remnants of the gilt star mouldings are still attached to the blue painted border. One fallen star is currently placed by the pipes, to the left of the central shaft.

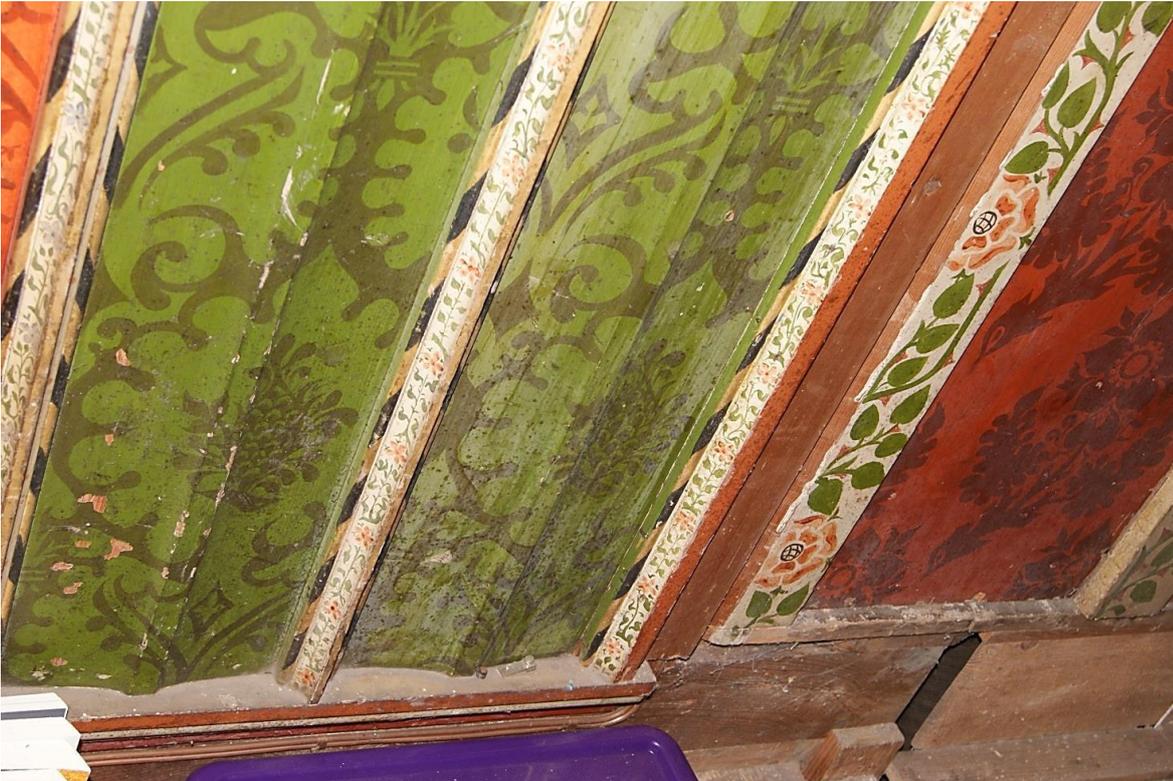
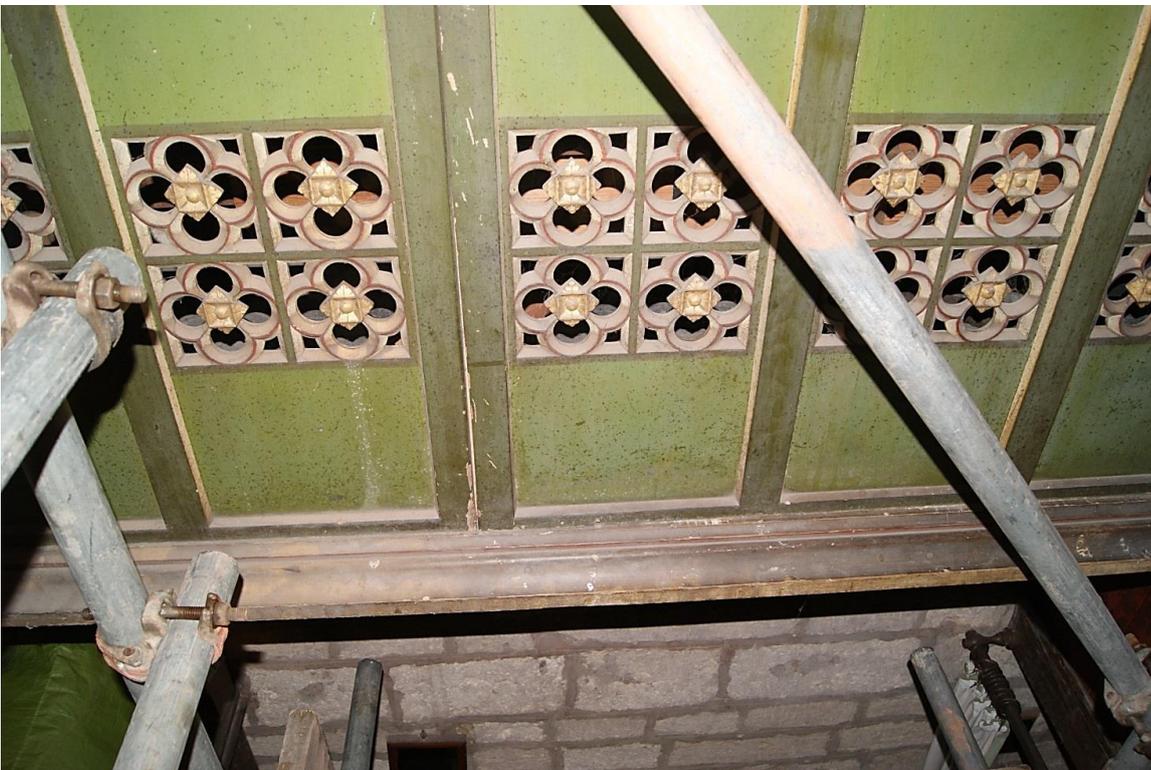
Right hand side of the organ balcony and panelling showing evidence of wear and tear, local impact abrasion damages, surface dirt and liquid splatter stains.

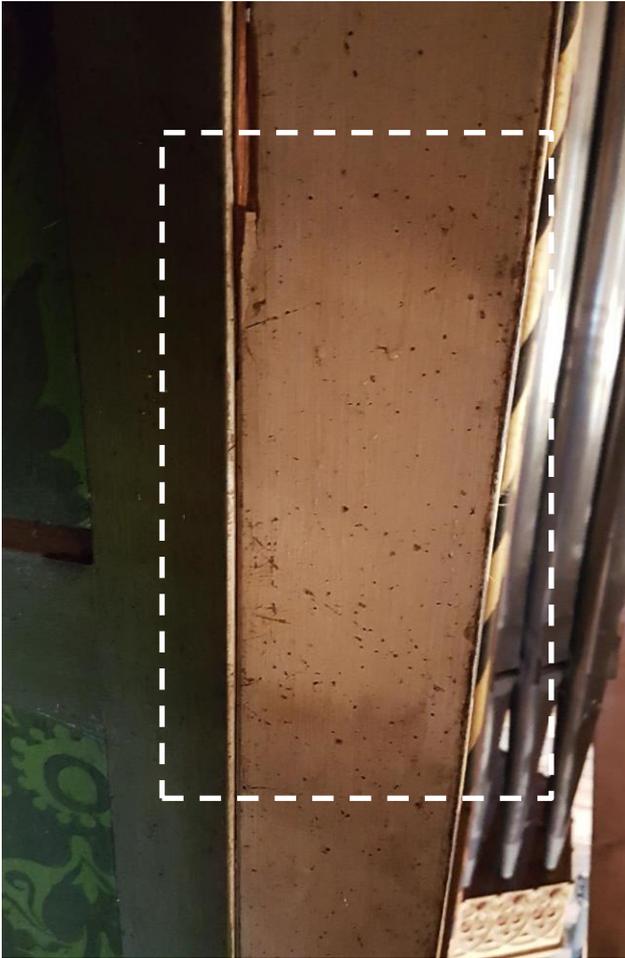
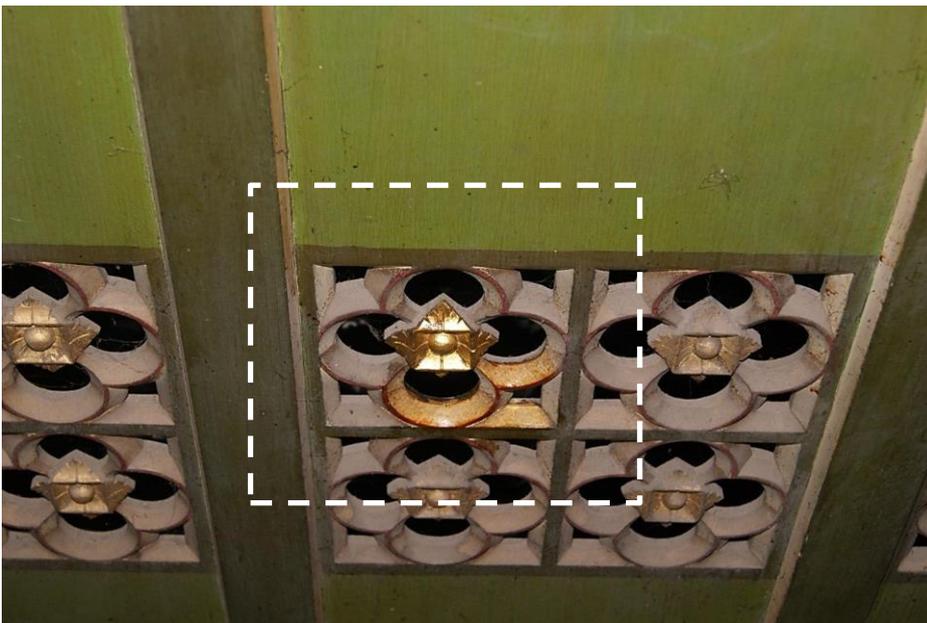
There is a substantial amount of surface dirt comprising accumulations of dust and sooty particulates. It is thinner and more even over lower areas, but more noticeable as patchy grey layers at higher regions. It is generally contributing to desaturation of the original colours. Accumulations of fly and spider surface deposits also exacerbate the unevenness and discolouration to the rich and saturated original tones. The extant coating is yellowed

Sites of surface cleaning tests to clear dirt accumulation, extensive fly spots and spider web residues. The latter will require targeted cleaning agents.

A programme of surface cleaning would be advisable, to remove the thick surface deposits. Long-term, these attract pollutants and moisture, and will contribute to the eventual degradation of the paint work. The wax will also need to be removed. Although the varnish coating oxidised, becoming more yellow, opaque and more solvent-resistant with age, the original colours, in particular the thinly painted reds, are sensitive to cleaning with solvents. Therefore it would be advisable to limit the cleaning to vacuuming and aqueous surface dirt removal until new safer and more effective methods for the removal of varnish is developed in the future. The fly and spider specks appear slightly ingrained on the surface and will require a tailored cleaning system to effectively remove them.

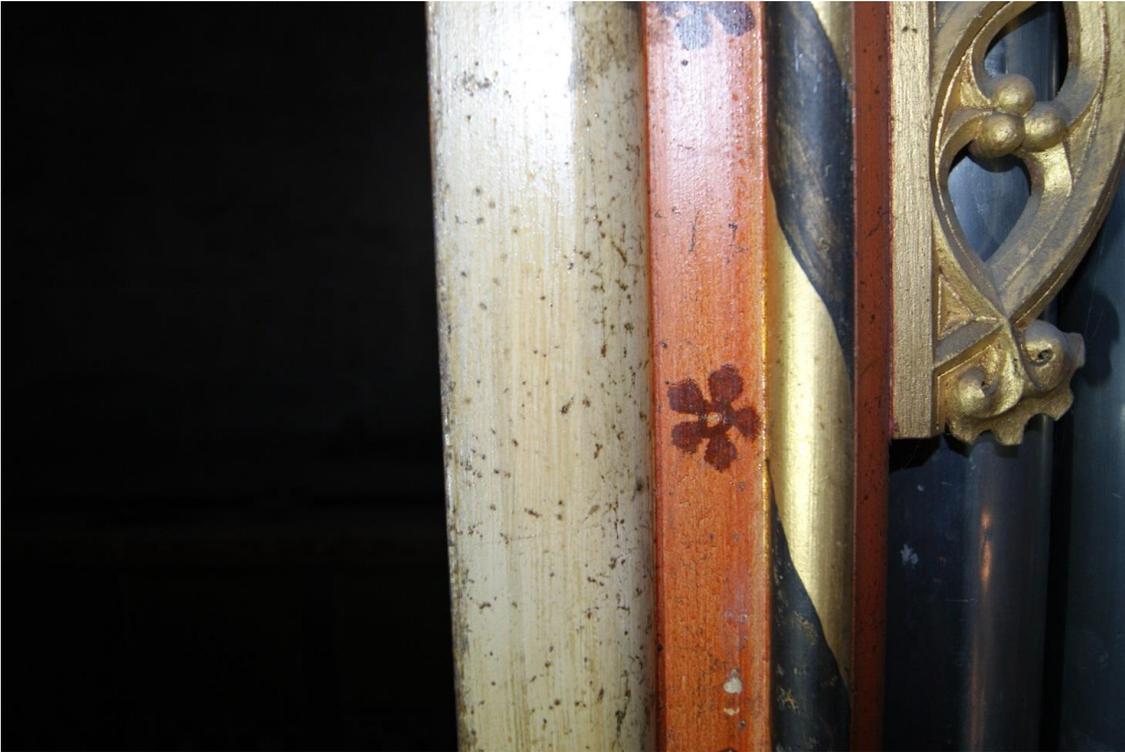
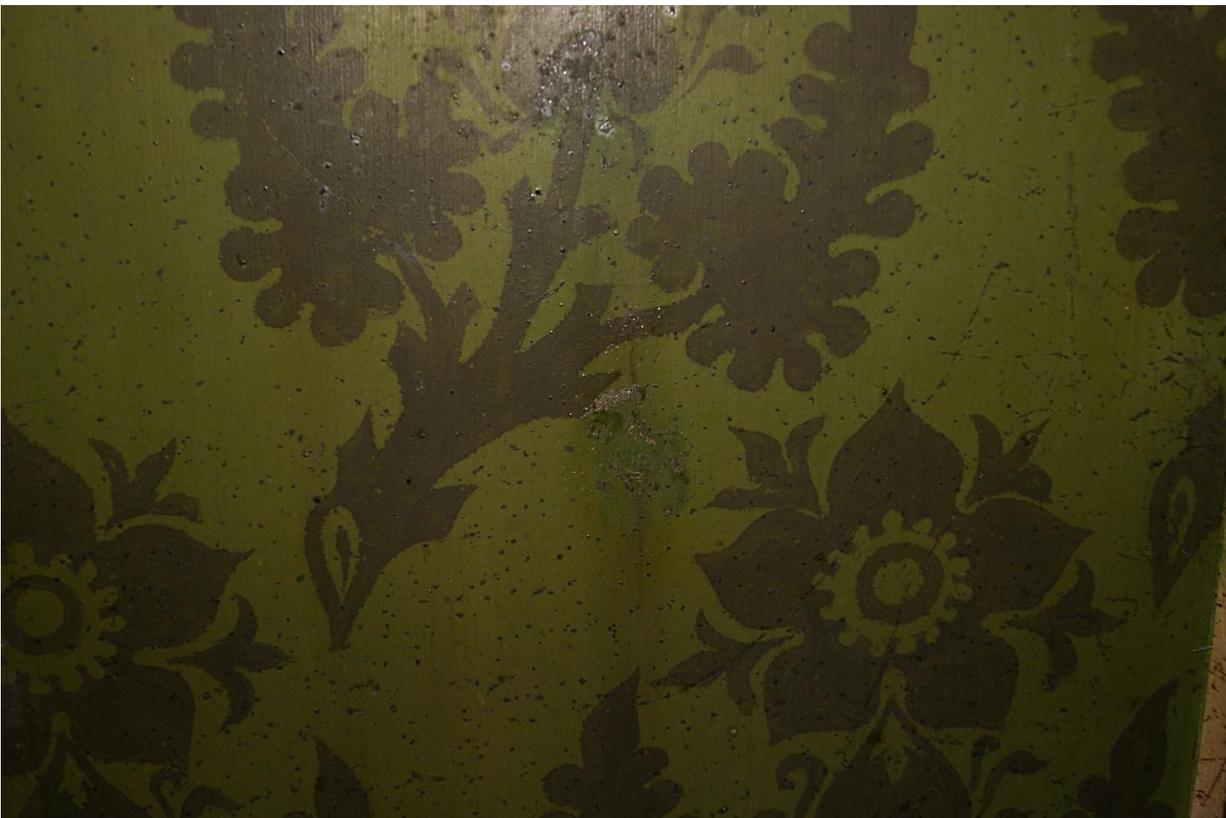
Images showing evidence of fly spots and spider web residues across the painted surfaces, in particular the upper section of the organ casing.

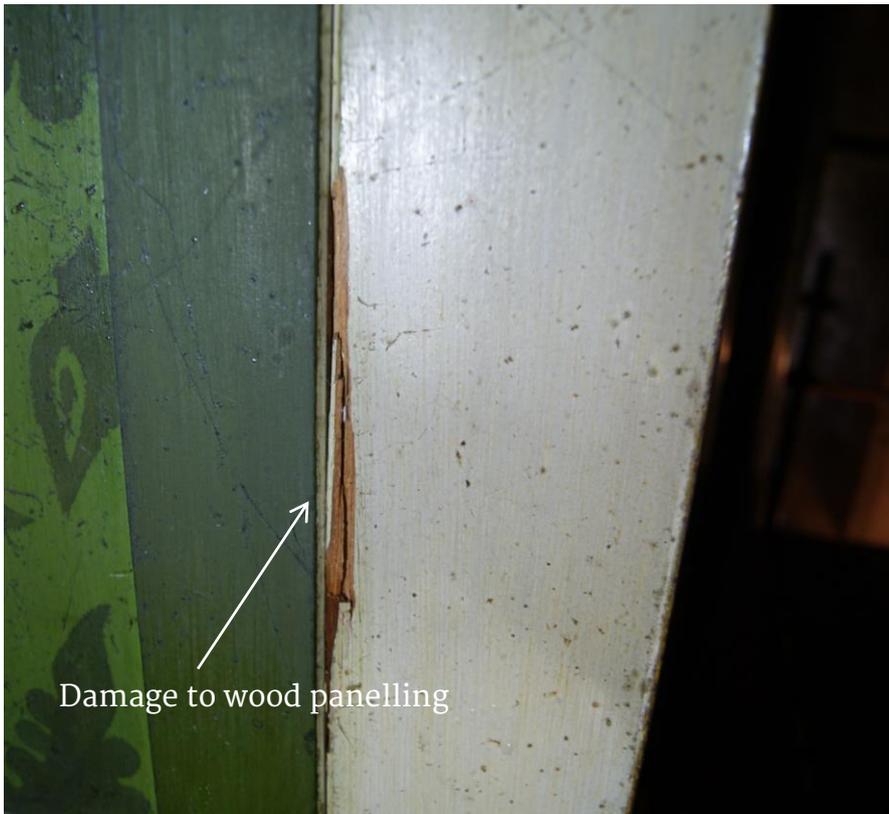
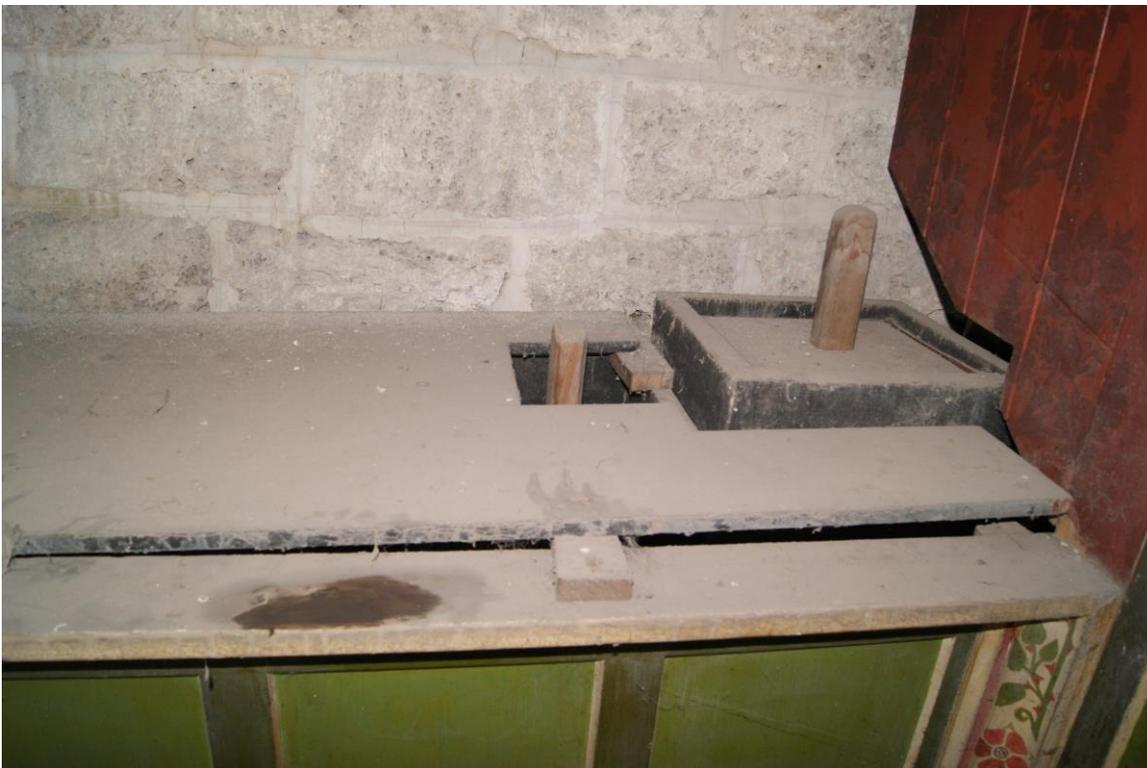
Several large screw heads are visible in a few locations but it is unclear whether they are original fixtures or have been added at a later date. There is a small damage visible to a board in the upper left side of the pipe casing, which appears to be the result of impact damage. A few profile sections are also slightly worn due to handling and usage.

Images showing minor area of damage to the wood support (above) and extensive accumulation of dirt above the left side panelling (below).

The wooden casing appears to have acclimatised to the variable environment within the church. Therefore, it is stable and should not be interfered with. Small losses to the wood would be filled prior to retouching with a conservation wood filler consisting of polyvinylacetate, coconut flour and microballons. The original wood surfaces should be isolated with a coating of Paraloid B72 varnish prior to filling with this mixture.
