The Duplex Pipe Organ and Blower Company Ltd., 42, Weybourne Road, Farnham, Surrey. GU9 9HG

Monday, 26 October 2020

The Engine of St. Michael and All Angels, Moccas

The Restoration

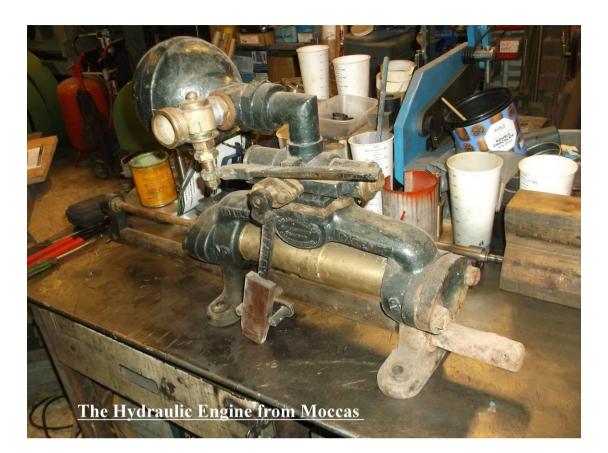
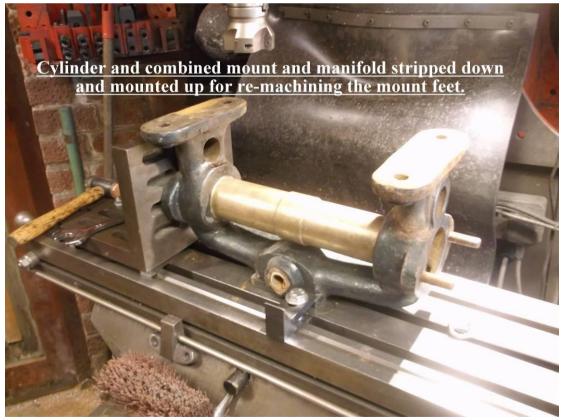
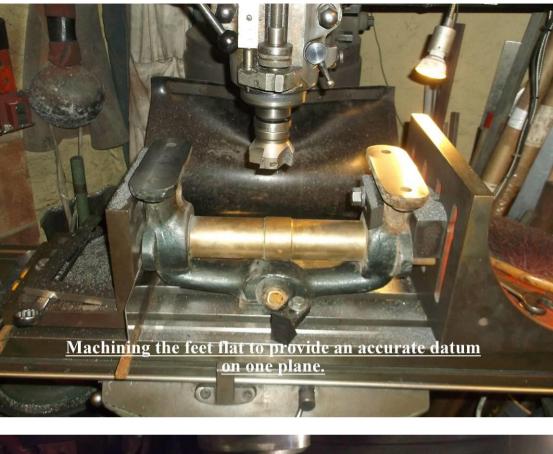
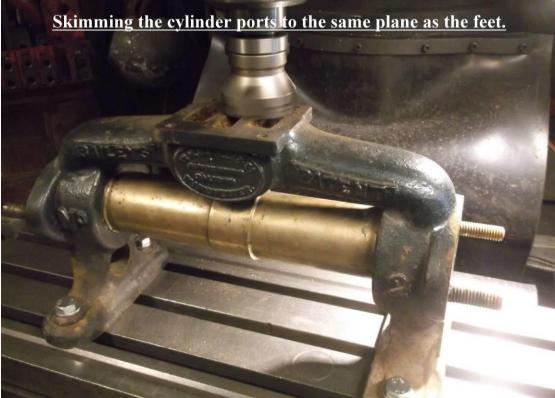
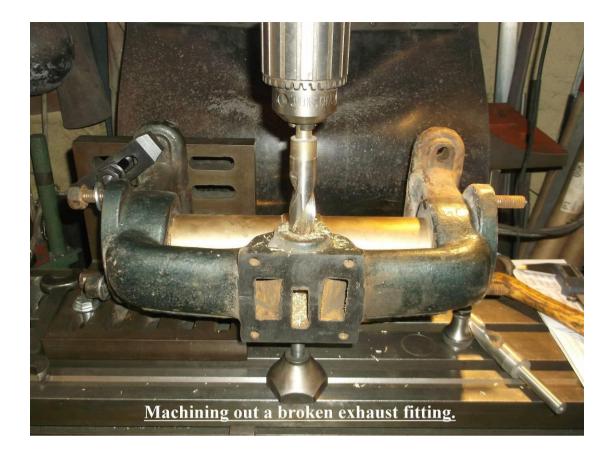
Having dismantled the engine into all its various components the main casting was tackled first. The mounting feet were simply in the rough cast condition, the valve box seat corroded and pitted and the guide bores, for the main guide rod, also badly pitted. So the first stage was to machine one true, flat surface from which all others could be referenced. The cylinder port was the largest originally machined area so this was used as the reference to machine both feet flat. The exhaust and intake surfaces, again in the rough cast condition and, in the case of the exhaust, having the broken end of the brass connection pipe stuck fast, were machined out and flat ready for new fittings. Then the cylinder port itself could be skimmed flat and finally the bore was aligned on the milling machine to bore out the guides for the guide bar and any broken cylinder studs.

The next port of call was to remove the previous paint work and clean and strip back all the parts to bare metal so that they could be examined in greater detail. The first stage in this process was to boil all the items in strong soda and steam clean them. This process removes paint, oil and grease whilst leaving the items untouched. The cast iron parts were blast cleaned with fine aluminium oxide having protected any vulnerable surfaces. In the case of the main casting this meant protecting the bronze cylinder barrel. This item was machined to a close fit in the cast iron casting when first made and then fixed and sealed in position by peening out the ends of the cylinder. This meant it could not be removed and so the outer surface was heavily masked against the abrasive and the ends of the cylinder plugged to protect the bore.

The old guide bar was to be replaced with a pattern made guide in corrosion resistant stainless steel so the casting guide holes needed bushing. The casting was set up in line with the axis of the milling machine and the original holes bored to suit new sintered bronze bushes.

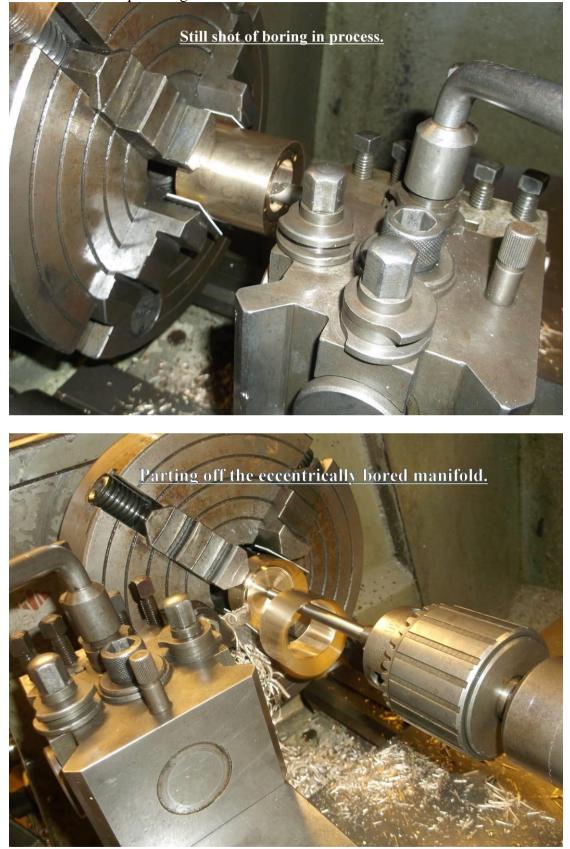
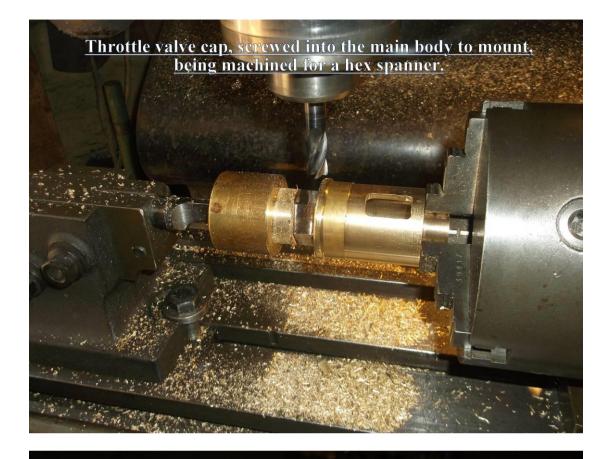
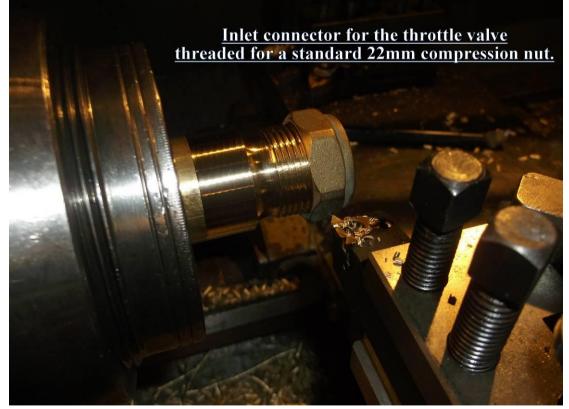
Then came the manufacture of the new throttle valve. The original was a cast item of lantern type but clearly casting a new one would be out of the question so a way of fabricating the new valve as close to the original had to be the solution.

The fabrication required eight different items all machined from solid brass.

The four components of the valve body were then silver soldered together before final boring of the through water passages.

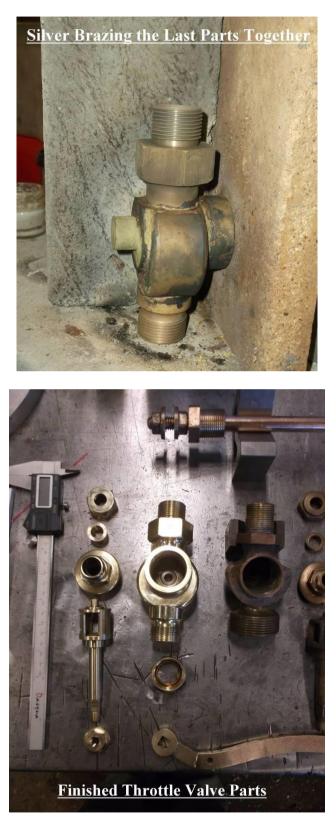
The control arm for the original valve had also been broken and badly repaired with plates and soft solder so this was repaired with new sections machined and silver brazed to the salvaged arm.
