The Duplex Pipe Organ and Blower Company Ltd.

Report on the Hydraulic Engine & Blowing Unit at St. Michael and All Angels, Moccas.

Hydraulic General Inspection

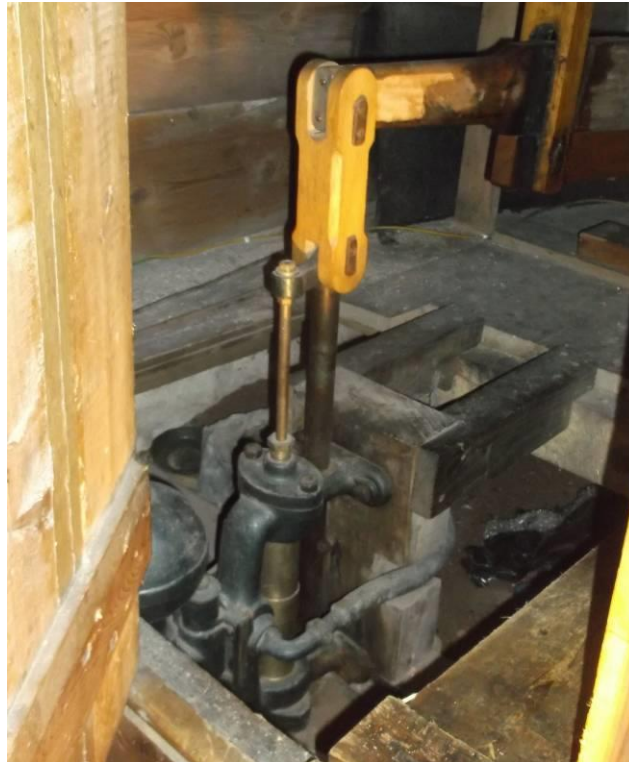
The engine is of unusual design, compared to the five others we have rebuilt, having a rigid slide bar connected to the piston rod, to keep the action straight, and what appears to be cast iron cylinder end plates and ports. Beyond that the design has all the typical parts including throttle valve, piston valve actuator, piston valve and main cylinder. The original connection rods and levers for the throttle control seem to be missing and this could require a more circumspect survey to assess for replacements.

- General rebuild of hydraulic engine with all new stainless fixings machined to match the original, new leather seals throughout, new gaskets throughout, new gland packings and pattern made parts to replace defective items and new control rods and levers for the throttle connection to the reservoir.

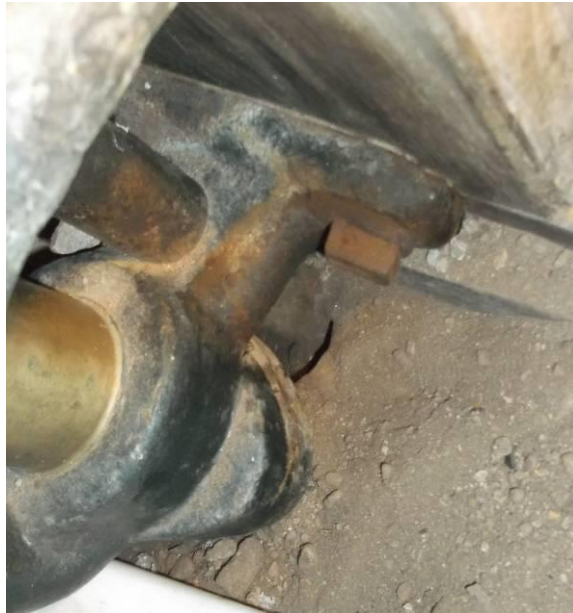
Main areas of concern with the engine are the cast iron parts and the old guide rod. The guide rod appears to have had a hole bored for it in the floor so that at the lowest position the rod can travel down far enough. The hole has become filled with accumulated debris with the rod part way down so I suspect there will have been considerable corrosion and hence the rod may well have to be replaced. It is impossible to tell the general condition of the internal

parts of the engine and the presence of so much cast iron may mean that valve gear has suffered.

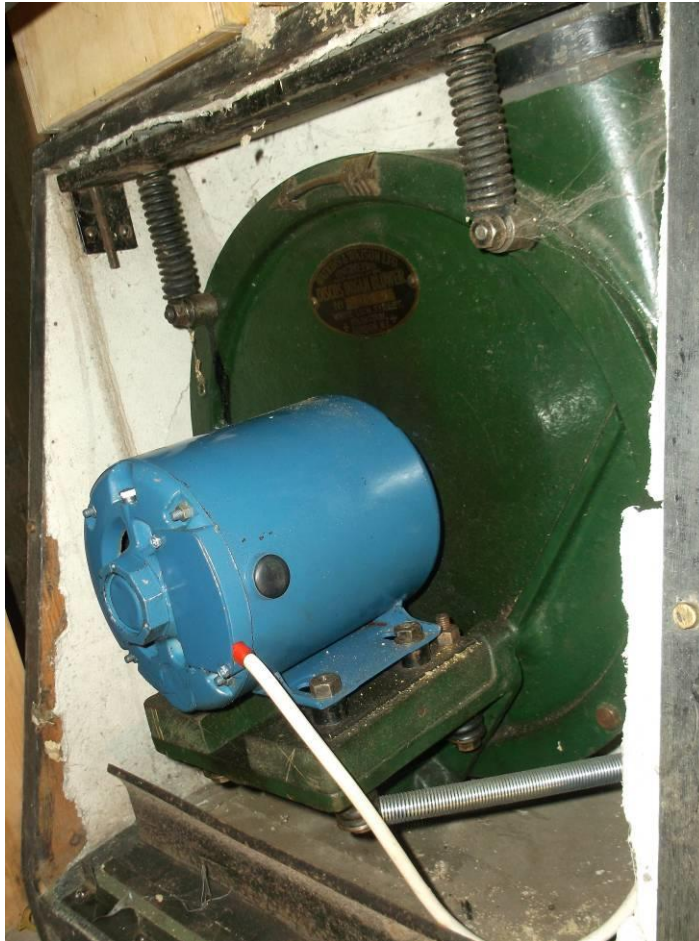
The blower on the organ is a small suspended Discus from the 1930's. At some point in its history the motor has been replaced with a modern equivalent. Unfortunately, the new motor does not the same slip speed as the original and hence the output, both CFM and static pressure, is reduced. It is currently in a old enclosure of all timber construction and, typically for the age, this structure has been lined with a thin, friable and damaged material, which I strongly suspect is asbestos bearing. In all cases where asbestos is suspected we would recommend testing of a small sample and if necessary disposal of the enclosure. Due to the nature of the material, if it were found to contain asbestos, further testing of the organ

winding system should be carried out to ensure contamination has not spread. This is not an onerous task requiring only small dust samples to be gathered from the main reservoir, additional reservoir in the job and the soundboards. Four or five samples should be sufficient. Test kits are available through UKAS approved laboratories on line and your organ builder should be able to assist with gathering the samples as parts of the organ will require opening up to gain access.

The blower itself can be removed, bagged and then dealt with separately. We would recommend rebuild of the original motor found on site, cleaning and overhaul of the blower and reinstatement of the original motor. We could then provide a new enclosure to mate up with the existing trunking.
