# THE CHURCH OF ST MICHAEL AND ALL ANGELS MOCCAS

### POST-CONSERVATION REPORT WINDOWS nIII and nIV August 2012

## JIM BUDD STAINED GLASS THE FOYCE GLADESTRY KINGTON HEREFORD HR5 3NS

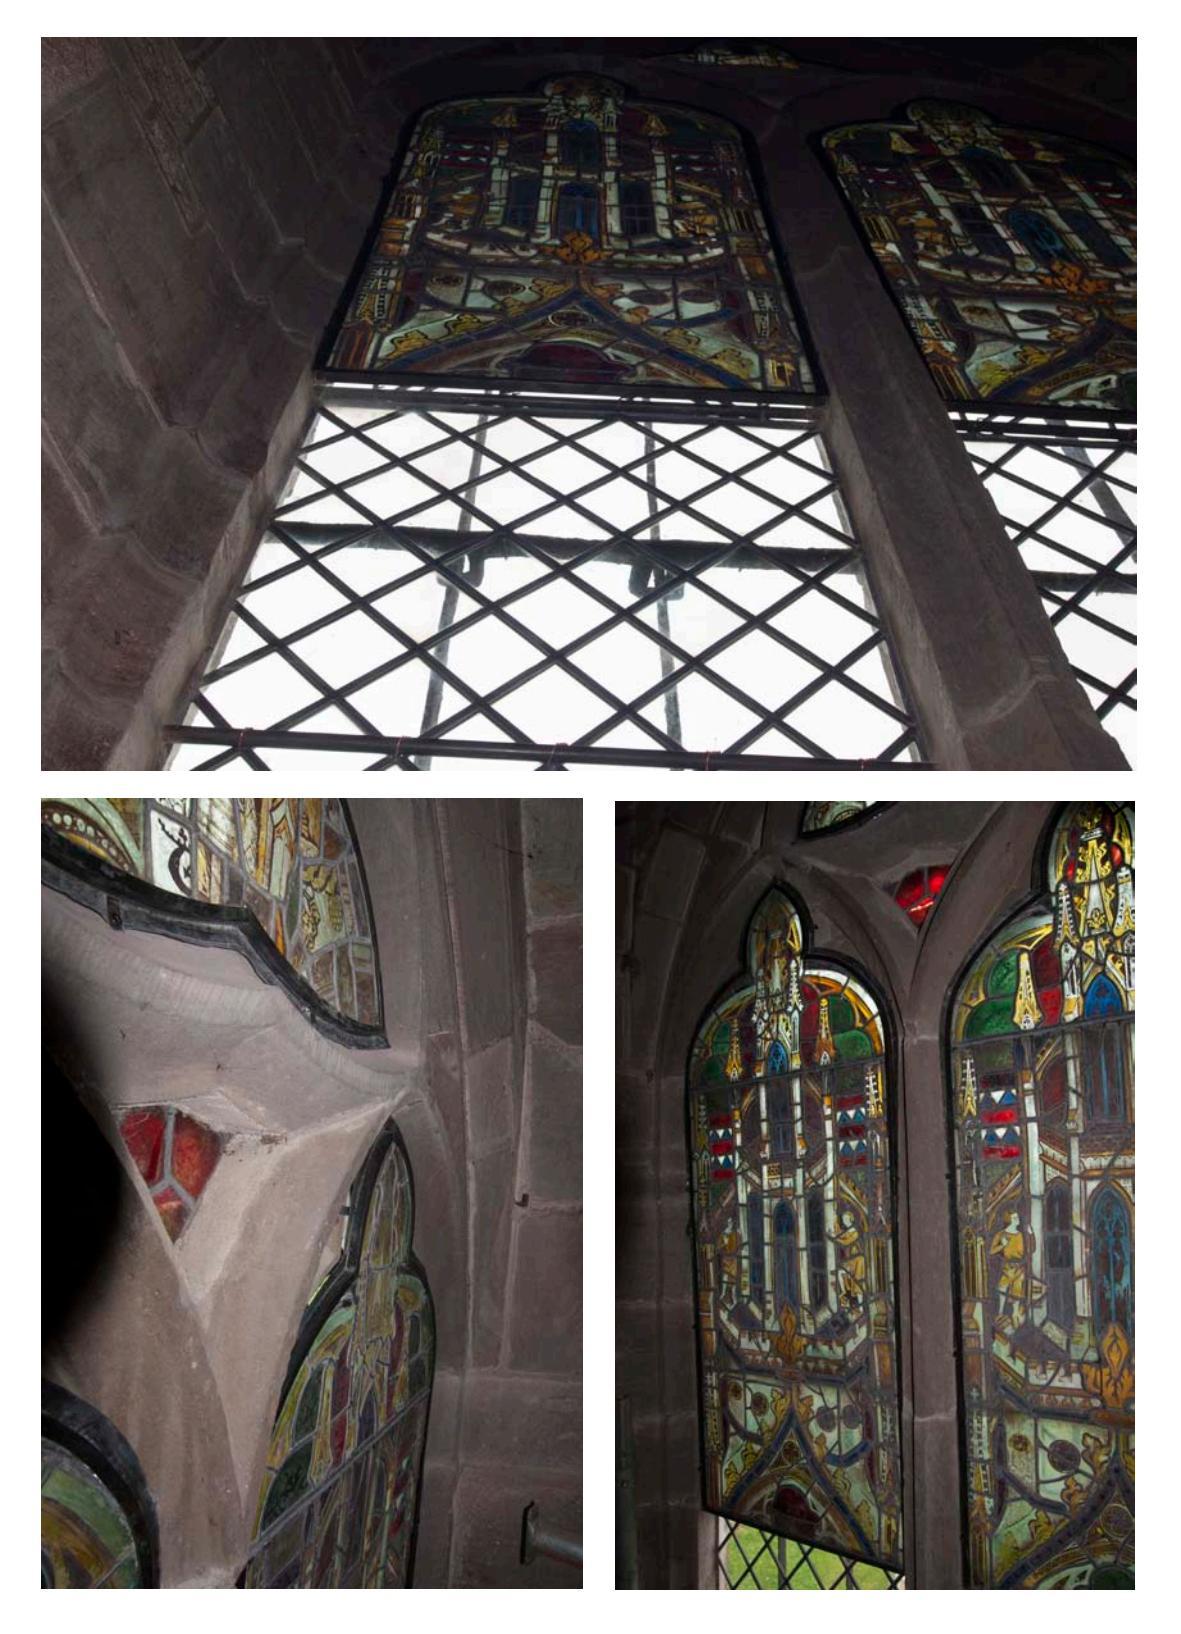
3,4,5. Window no. nIII. Details showing the 'tilted' isothermal framing installation (01/06/2012)

A large number of options were considered for the framing of the panels. During the project plannng process discussions were held with Andrew Arrol, who has extensive first hand experience of framing options through his work on the stained glass art York Minster. It was decided to try to tilt the panels to allow equal ventilation gaps at the bottom and top of the panels. This became the preferred option as it required the least intervention to the original panels, whilst achieving a reasonably low visual impact internally, in this well lit and quite intimate building. Options considered were: 1. To split the main panels and the head panels allowing a ventilation gap between the two panels. 2. To create raised ventilation points within the panels, by partial extraction/raising of pieces within the panel 3. To frame the panels and to set them approximately 12mm forward from the inner arris of the masonry in order to accommodate a sufficient air gap at the head of the panel.

The heads of the panels contained no 'sacrificial' border glass unlike the lower main panels and so the heads could in no way be accommodated within the masonry reveal without significant cutting of the original medieval glass which was considered to be unacceptable. It was clear that the shape of the head panels had been re-shaped in the nineteenth century restoration. The preferred option was therefore to tilt the whole panel (lower panel and head) so that the lower panel was within the reveal and the head of the panel projected outwards beyond the arris to allow a gap for ventilation.

To make the heads of the panels fit into a frame that could be tilted it was necessary to cut a small amount of the original material from the 'shoulders' of the head panels, at the springing area. The loss was minimised by careful alignment of the panels and restricting the cutting to a single area of un-painted glass at each side. The small off-cuts are stored in the glazier's archive.

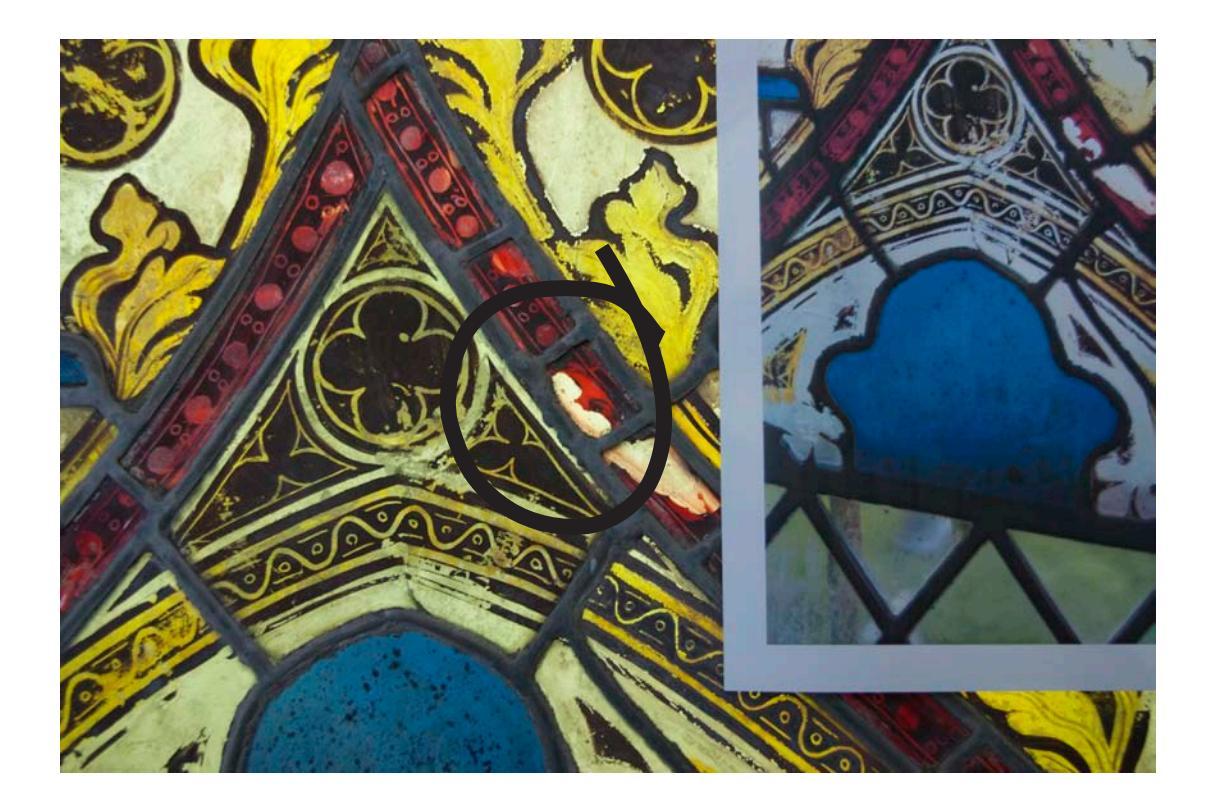
6. Window nIV panel 3a. fragment of red flash glass layer was found dislodged prior to the removal of the panels. This was saved and re-applied using Paraloid B72 adhesive.

When rubbings were being taken in situ a loose fragment of red glass 'flash'was removed and labelled . It was later reapplied with Paraloid b72 adhesive. (nIV panel 3a)

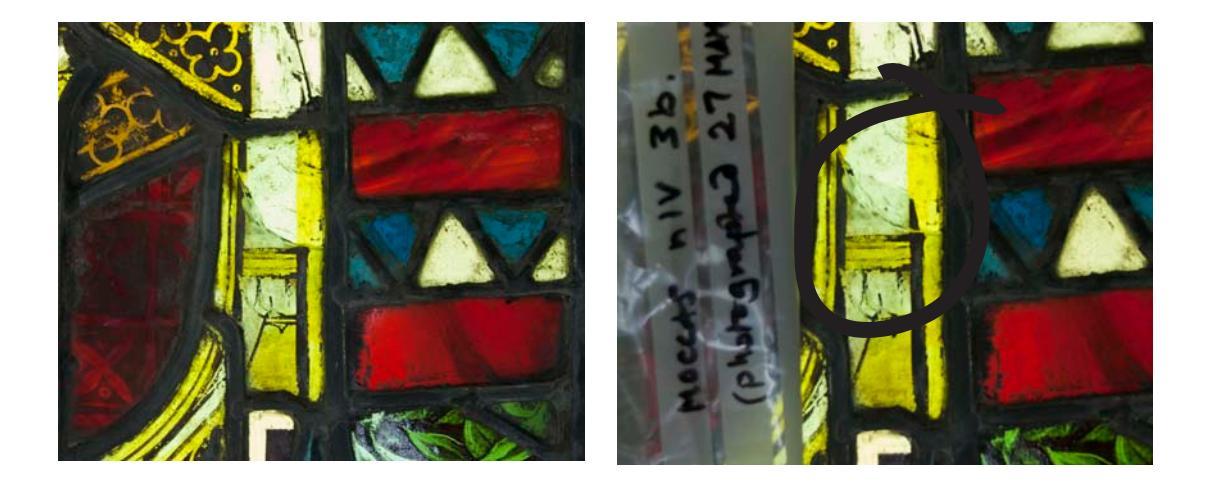
7.Window nIV panel 3b. fragment of 'shelled' glass re-applied with Paraloid B72 adhesive.

A shelled fragment of painted glass was re-applied with Paraloid b72 (nIV panel 3b)

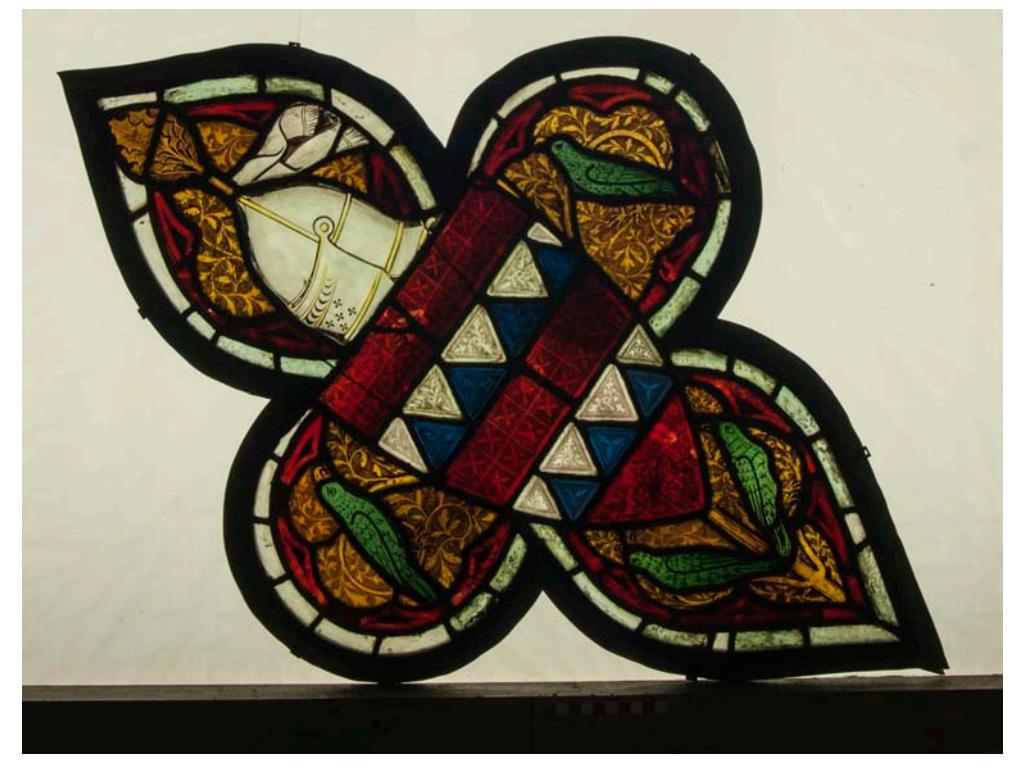
Window nIV Panel A2 - at completion of studio works. 29/05/2012

The tracery panel nIV, A2 had previously been glazed with the painted surface on the exterior, this had resulted in corrosion pitting. The pitted surfaces were cleaned by light blasting with compressed air and sodium hydrogen carbonate powder at 50 psi. This was monitored under a microscope . The air-brasive action was confined to pitted area s of the unpainted exterior of the glass. The opacity of the corrosion products was reduced but not completely removed, so as not to cause damage to the 'gel' layer of the glass.

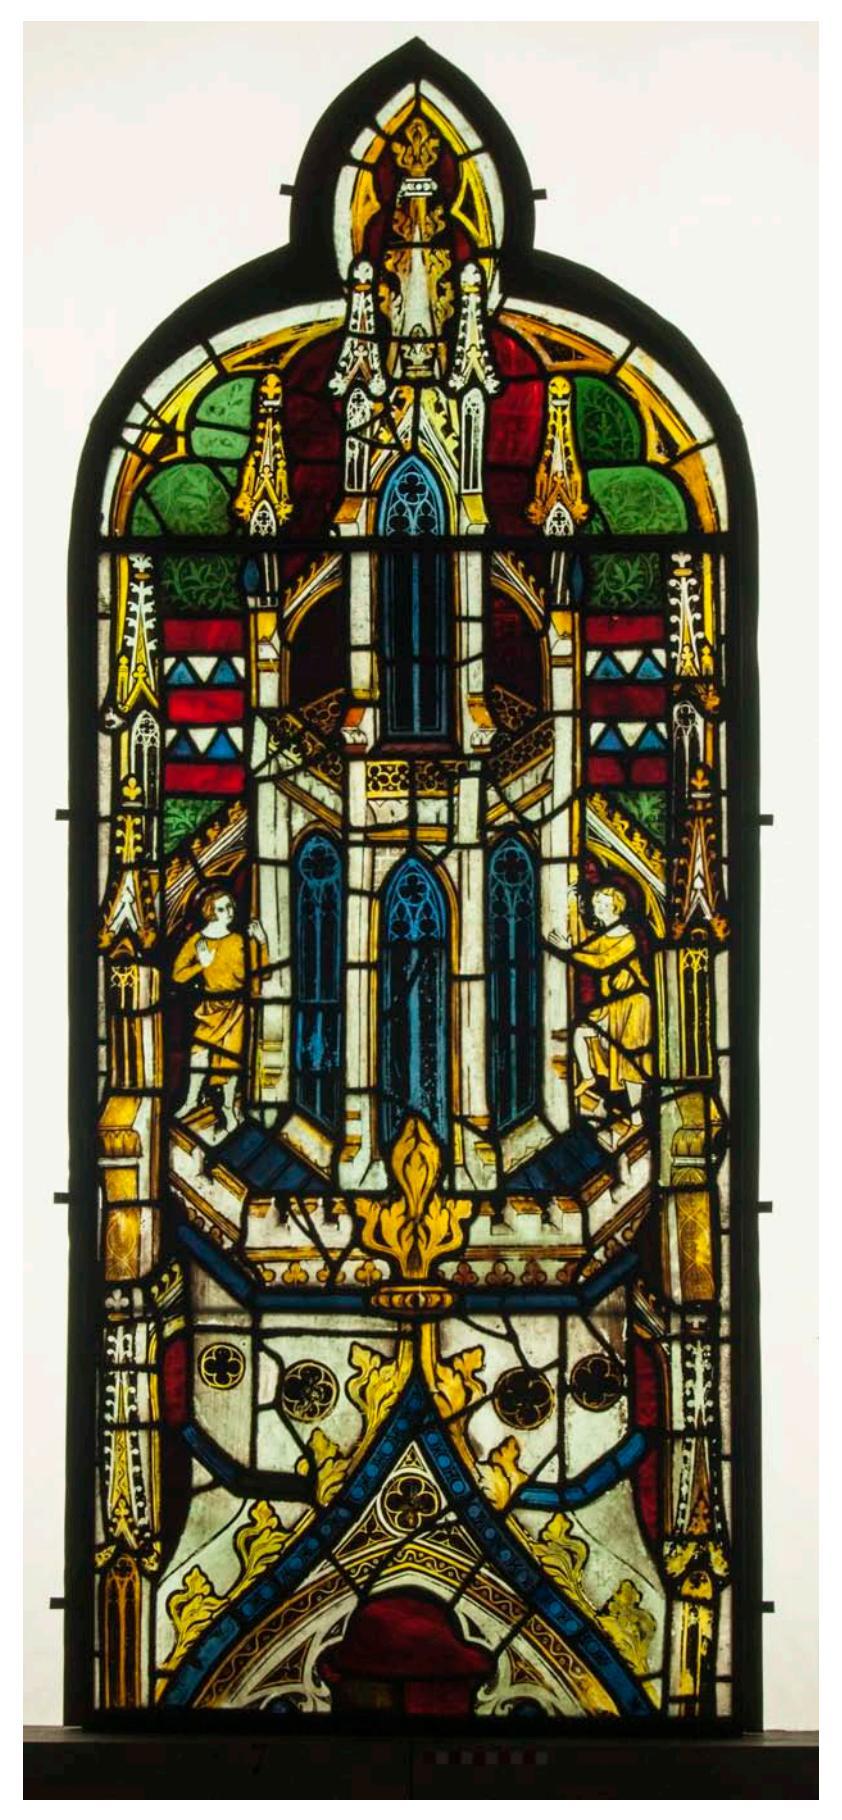
Window nIII Panels 2a & 3a - at completion of studio works. 29/05/2012

A cracked and unstable piece of glass was edge-bonded with silicone adhesive. (nIII panel 3a)

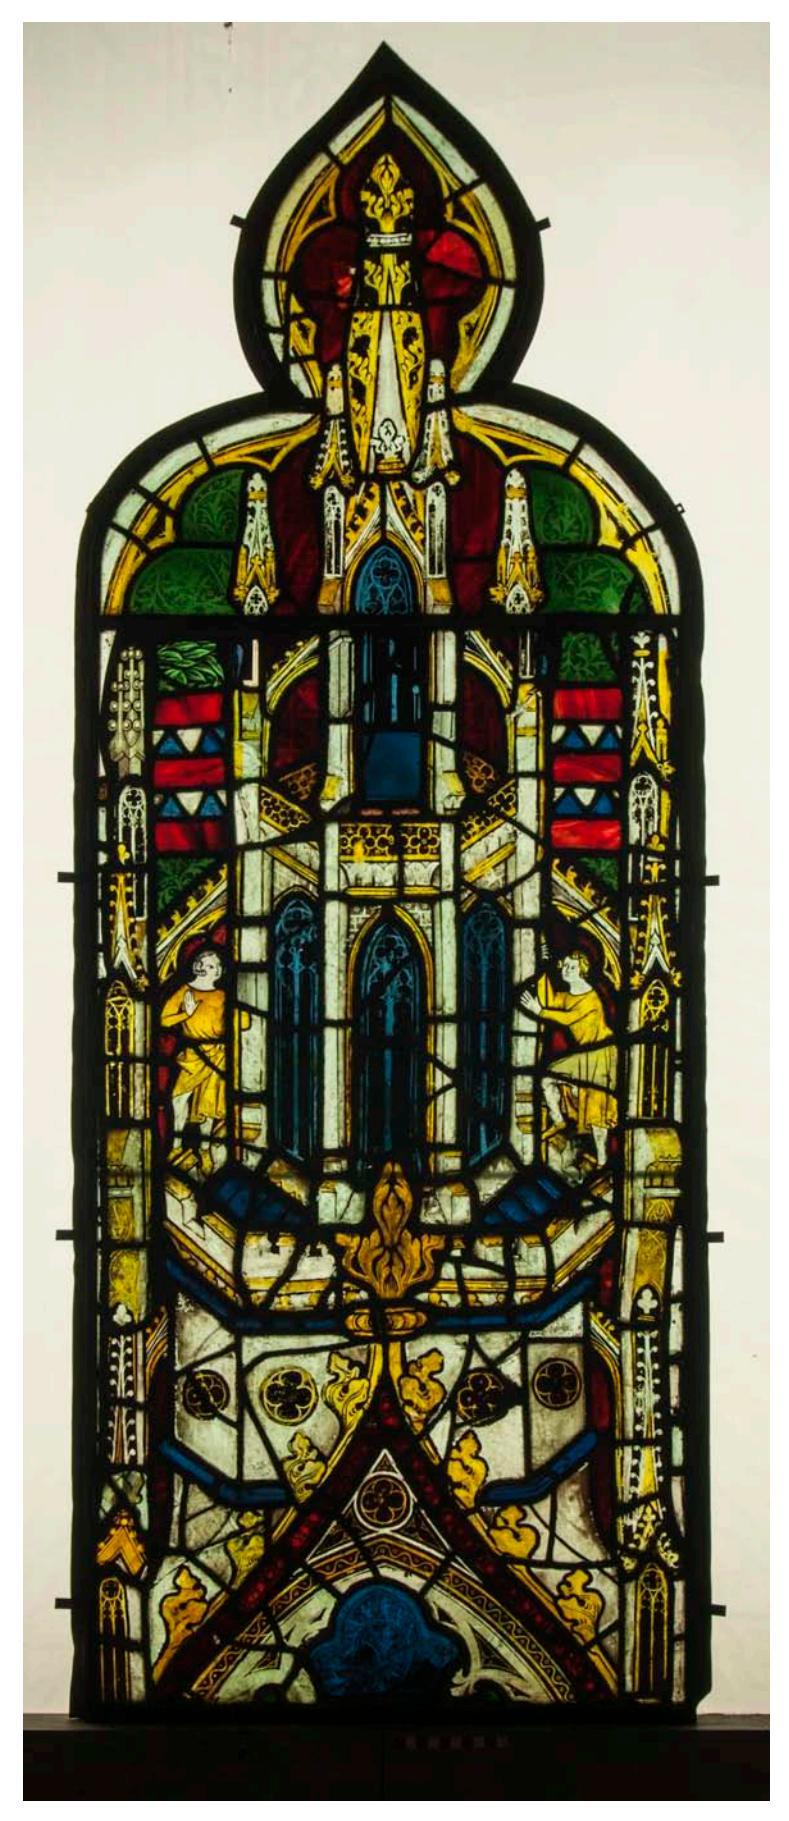
Window nIV Panels 3b & 4b - at completion of studio works. 29/05/2012

nIV panel 3b was worked on to reduce the visual impact of the leading. This panel had been repaired in the last 50 years or so using thick leads and very poorly applied (smeared) leaded light cement. The leads and smeared cement were pared back with scalpels and knives to 'lighten' the panel without the intervention of re-leading.
