NICHOLSON & Co.

PIPE ORGAN BUILDERS

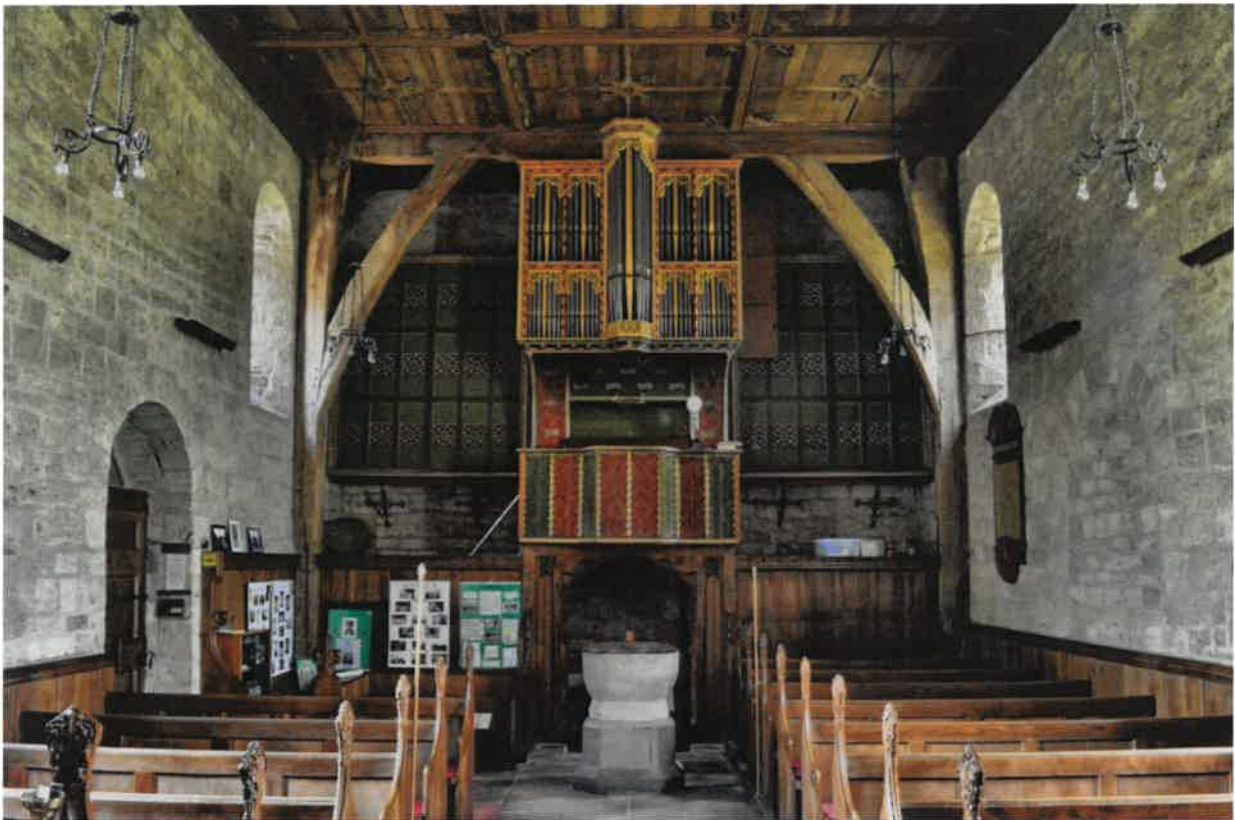
The organ in St Michael's Church in Moccas dates from 1871 and was installed during the course of a comprehensive restoration of the church building under the guidance of George Gilbert Scott Jr. The organ was built by the London firm of J.W. Walker & Sons who were among the pre-eminent English organ builders of the mid-19th century.

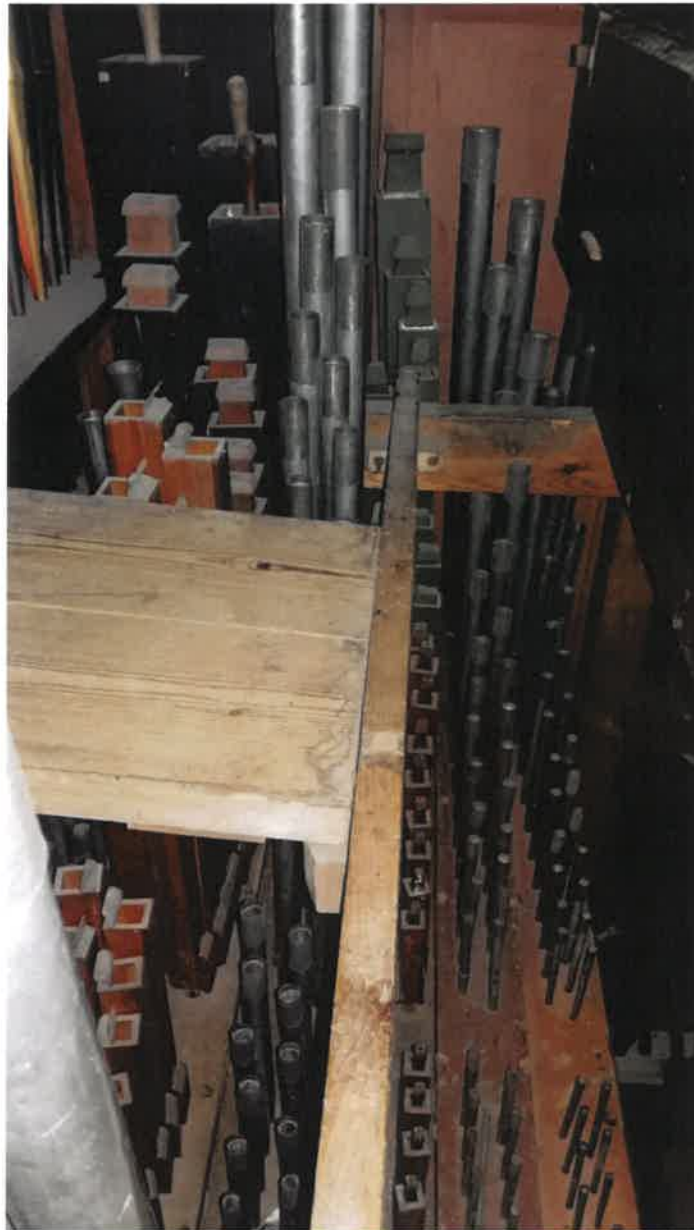
*Great Organ pipework, with tuning platform and rear of façade pipes on the left
and the Swell Organ expression box on the right*

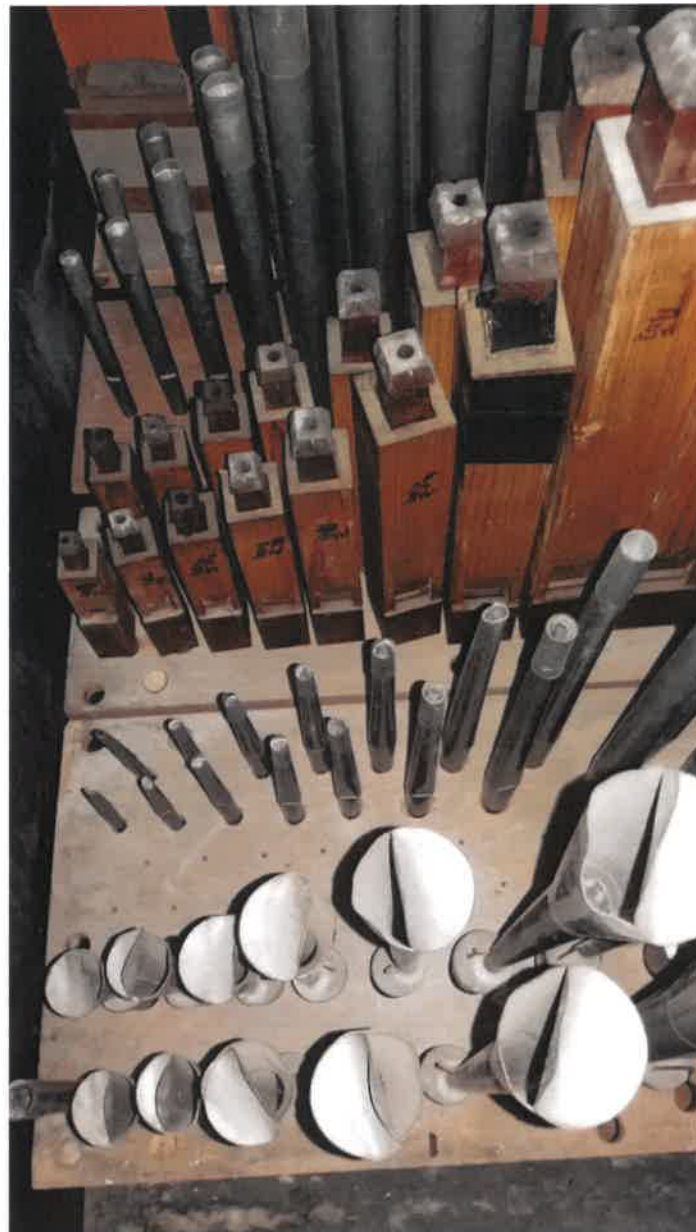
Part of Swell Organ pipework

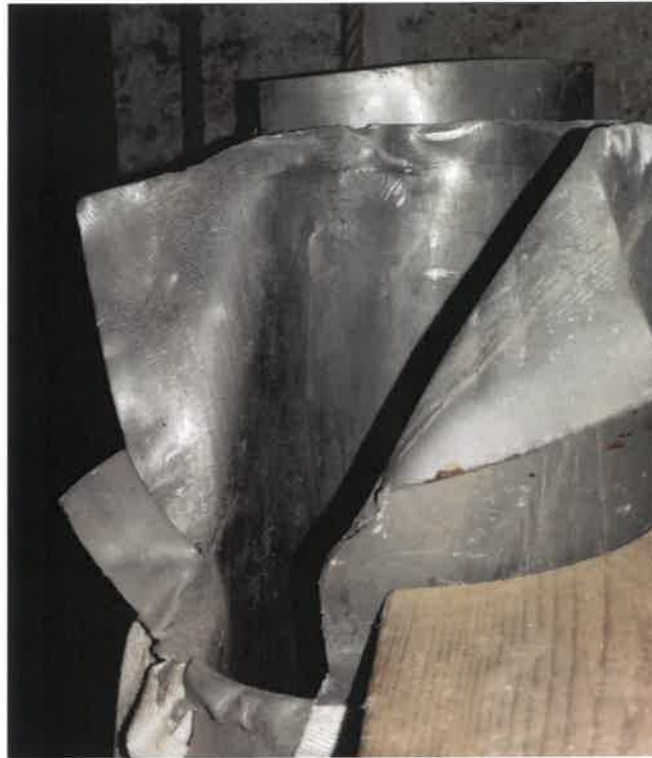
Damaged top of bass Open Diapason pipe

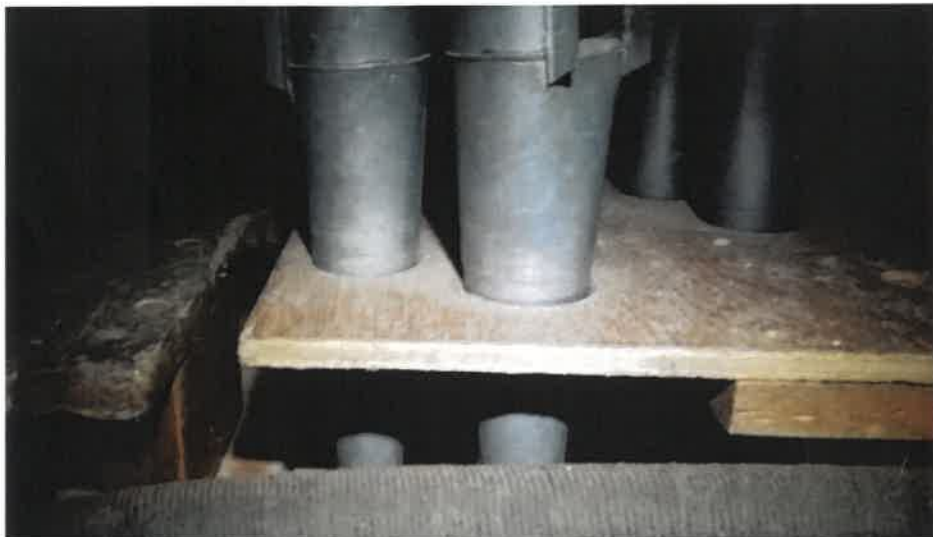
Original (left) and 1972 (right) rackboards

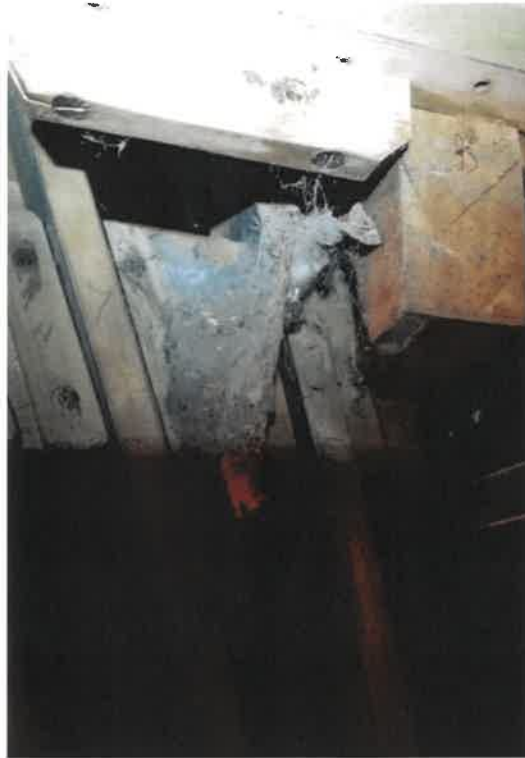
Slider lever arms, with notable cobweb

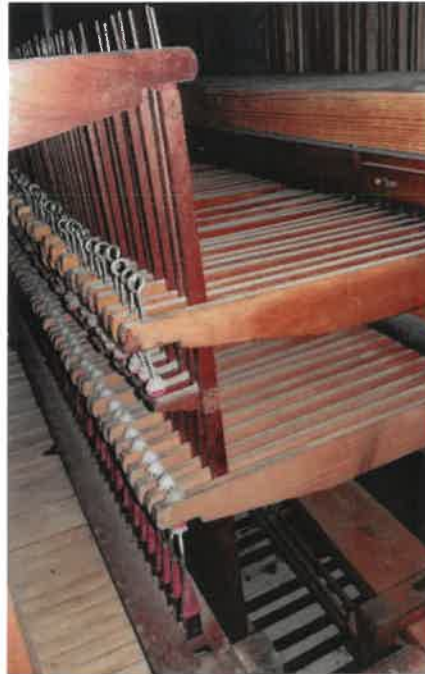
Coupling mechanism behind console (Swell keys visible at bottom of picture), with non-standard plastic buttons.

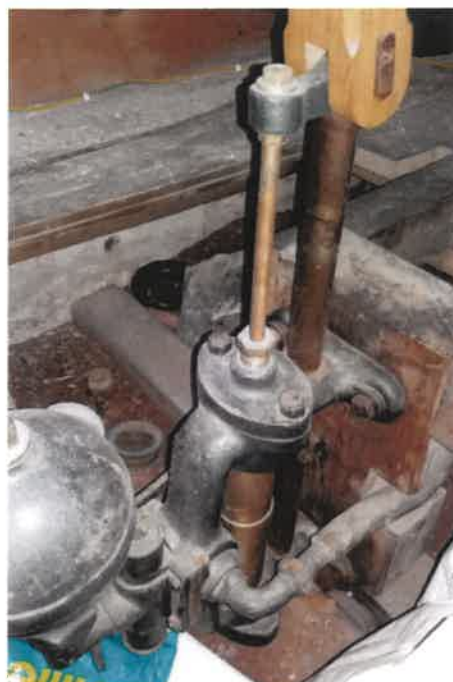
Wind for the organ pipes comes from a substantial double-rise reservoir (bellows) within the cupboard at the base of the organ on the opposite side of the console steps. This would originally have been blown by hydraulic power: the pressure of a mains water supply was used to move cranks that raised and lowered small bellows (known as feeders) underneath the reservoir to fill it. At some point an electric blower was fitted, to which a replacement electric motor appears to have been attached recently. During our visit we were advised that the organ remained water-powered until the 1960s. Interestingly, the Bailey's Patent water engine remains in place, though non-functional.

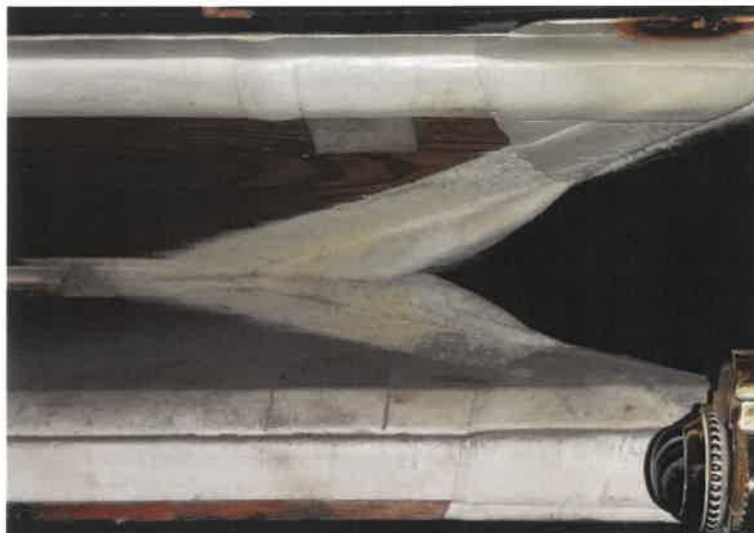
Mouldy and perishing leather on reservoir

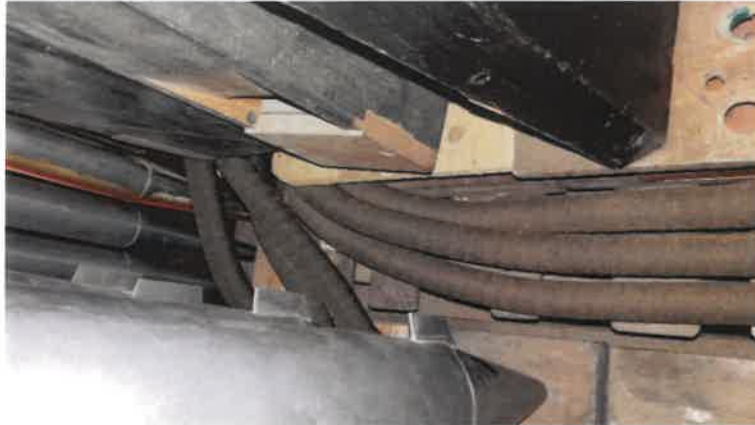
Flexible cardboard tubing to façade pipes

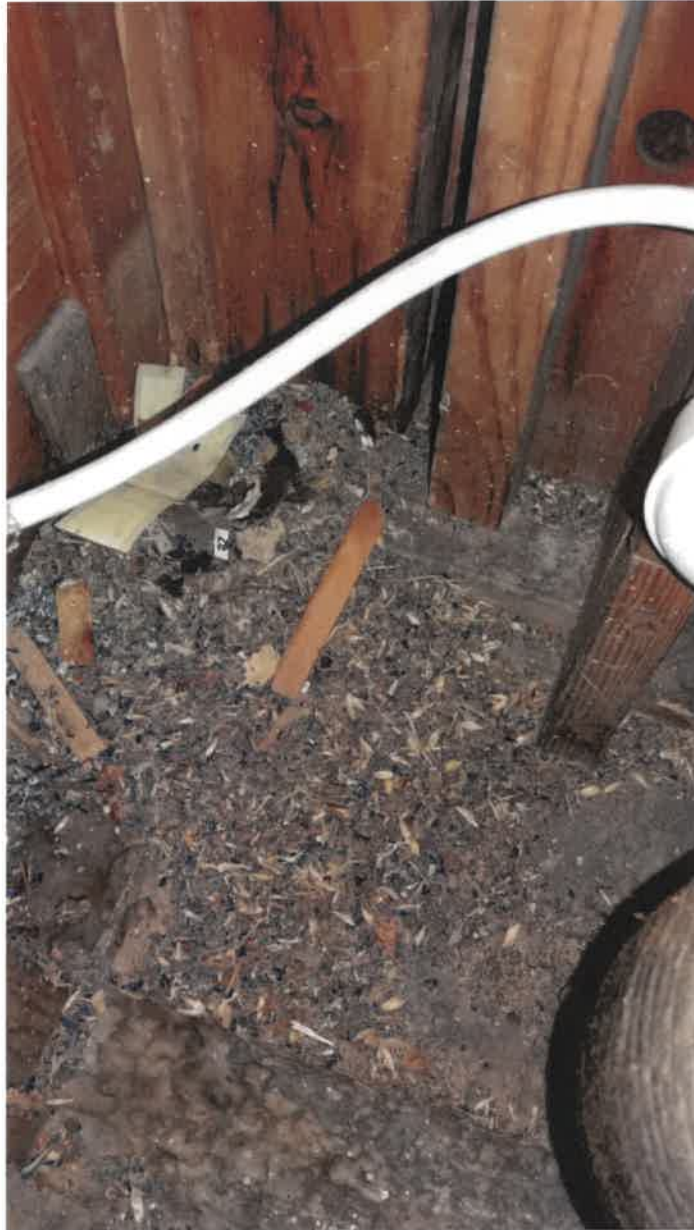
Interior of organ, showing mouse nest, urine stains, liberal quantities of (blue) poison, and woodworm

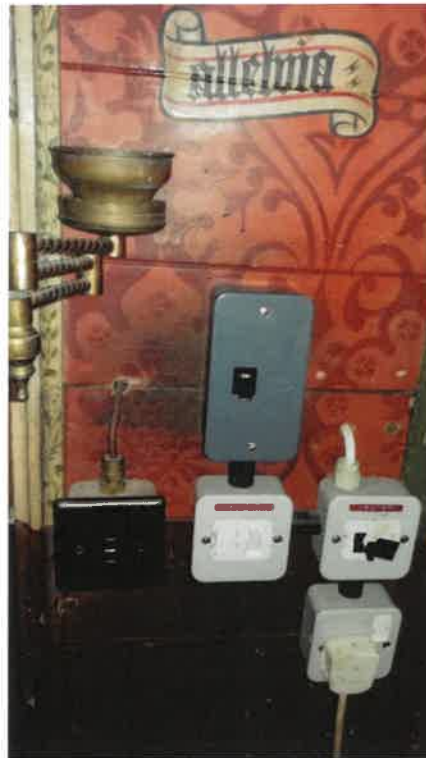
Variety of electrical fittings screwed into decorated case

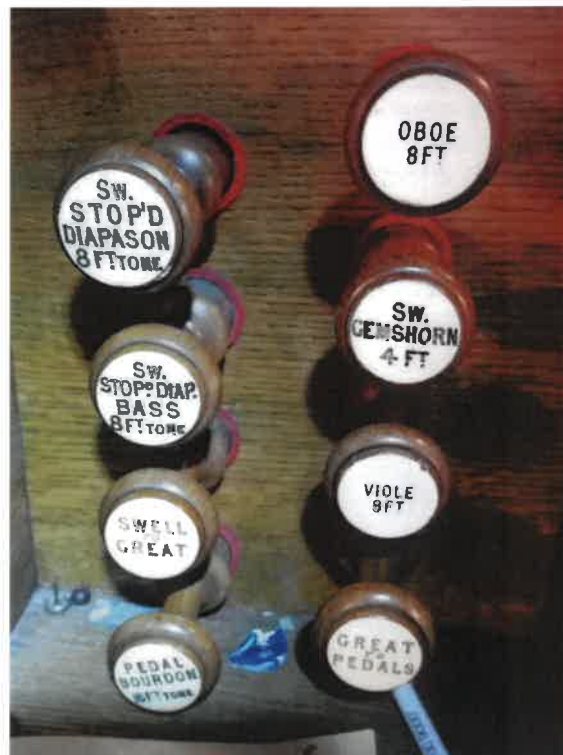
Variety of lettering on drawstop labels

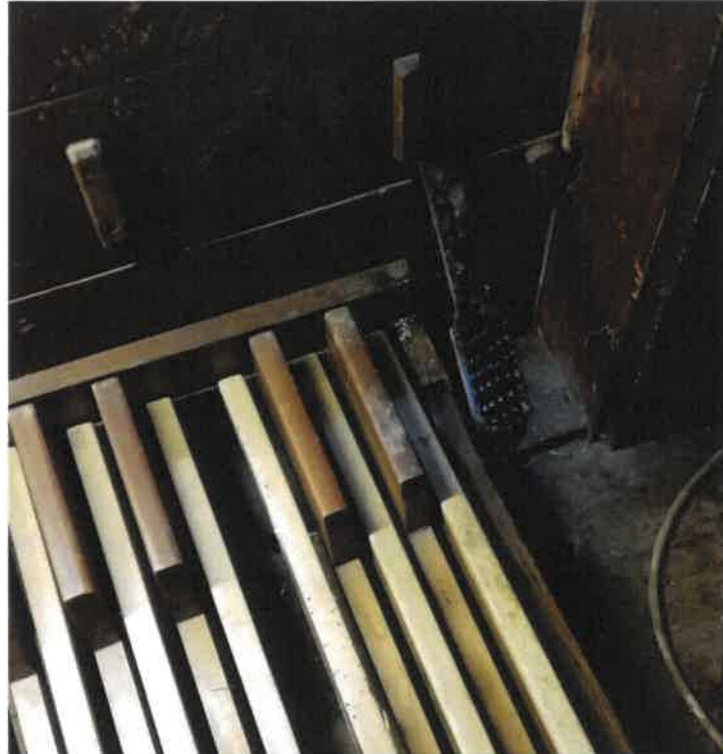
Pedal area showing non-original expression pedal and damaged woodwork

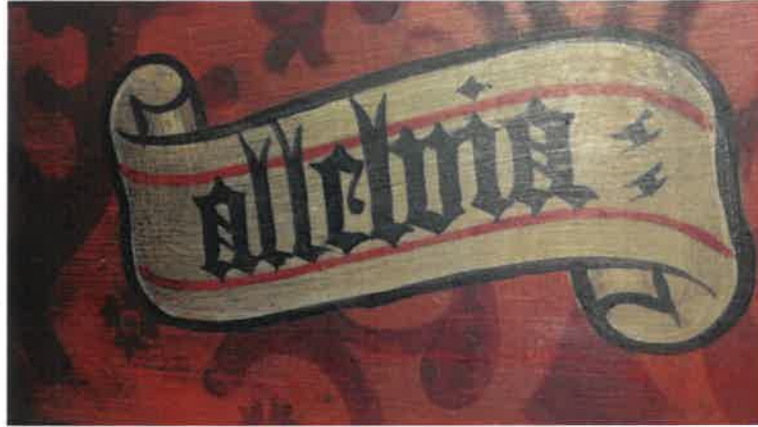
Pictures illustrating detail and condition of case decoration

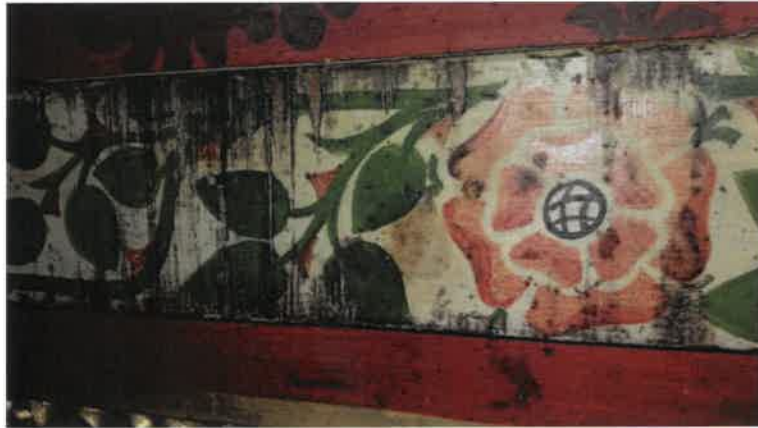
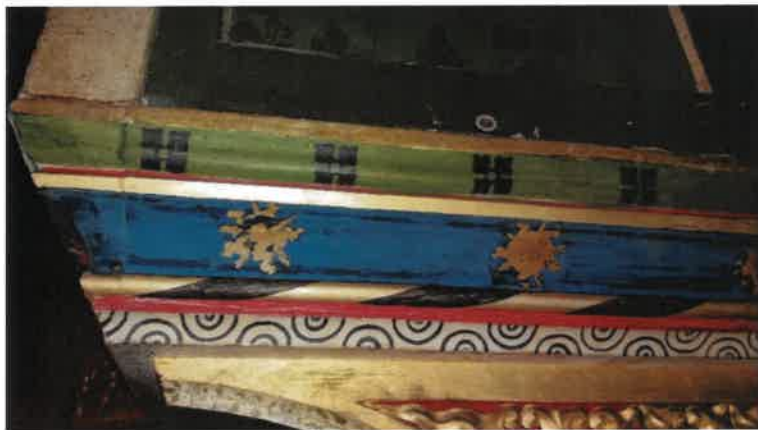
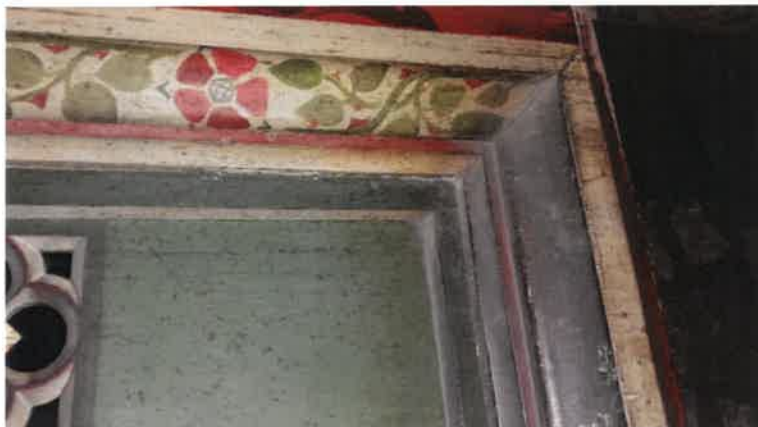
² www.elizabethholford.co.uk
