The Duplex Pipe Organ and Blower Company Ltd., 42, Weybourne Road, Farnham, Surrey. GU9 9HG

Monday, 26 October 2020

The Engine of St. Michael and All Angels, Moccas

The Restoration

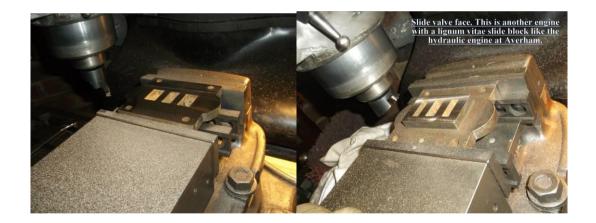
Cylinder studs, nuts and those for the valve chest were all remade in stainless steel. The valve plate and any mating machined surfaces were all remachined flat and true.
